# PIC18F6627/6722/8627/8722

## PIC18F6627/6722/8627/8722 Rev. A1 Silicon Errata

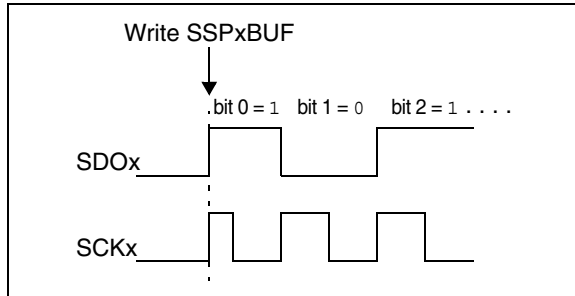
**FIGURE 1: SCKx PULSE VARIATION USING TIMER2/2**

When the SPI is using Timer2/2 as the clock source, a shorter than expected SCKx pulse may occur on the first bit of the transmitted/received data (Figure 1).

To avoid producing the short pulse, turn off Timer2 and clear the TMR2 register, load the SSPxBUF with the data to transmit and then turn Timer2 back on. Refer to Example 4 for sample code.
