## PIC18F87J50 Family Silicon Errata and Data Sheet Clarification

The PIC18F87J50 family devices that you have received conform functionally to the current Device Data Sheet (DS39775C), except for the anomalies described in this document.

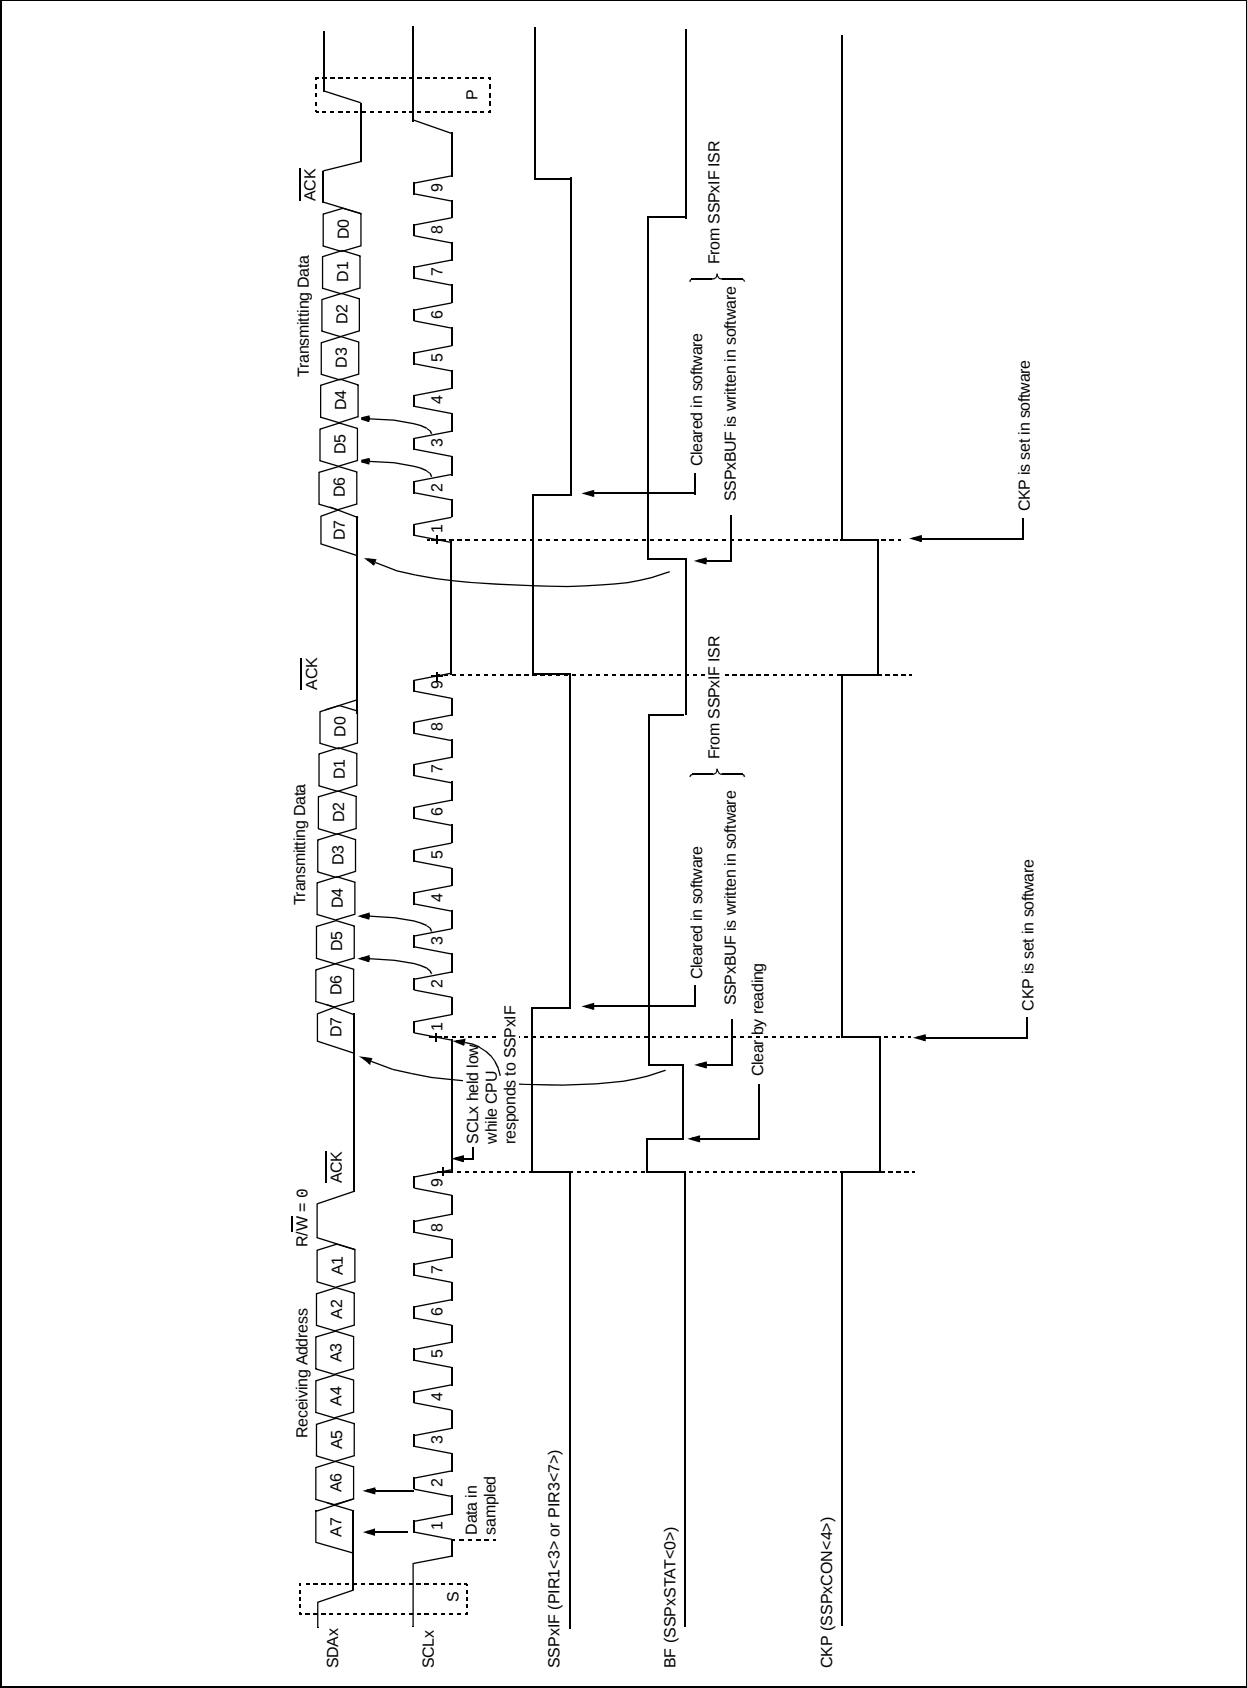
FIGURE 19-10: I<sup>2</sup>C™ SLAVE MODE TIMING (TRANSMISSION, 7-BIT ADDRESS)

On page 252, the figure is replaced with the new timing diagram provided in [Figure 19-10](#).
