# PIC18F2455/2550/4455/4550

## PIC18F2455/2550/4455/4550 Rev. A3 Silicon Errata

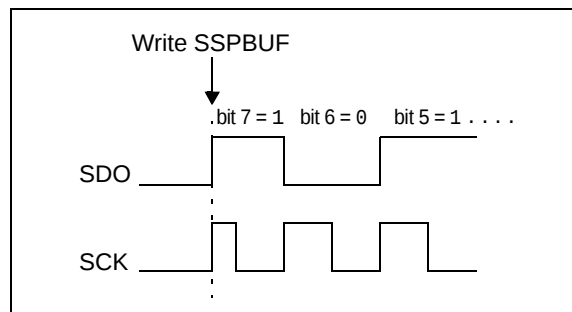
**FIGURE 1: SCK PULSE VARIATION USING TIMER2/2**

When the SPI is using Timer2/2 as the clock source, a shorter than expected SCK pulse may occur on the first bit of the transmitted/received data (Figure 1).

To avoid producing the short pulse, turn off Timer2 and clear the TMR2 register, load the SSPBUF with the data to transmit and then turn Timer2 back on. Refer to Example 6 for sample code.
