## PIC18F2515/2610/4515/4610 Rev. A3 Silicon Errata

The PIC18F2515/2610/4515/4610 Rev. A3 parts you have received conform functionally to the Device Data Sheet (DS39636D), except for the anomalies described below. Any Data Sheet Clarification issues related to the PIC18F2515/2610/4515/4610 will be reported in a separate Data Sheet errata. Please check the Microchip web site for any existing issues.

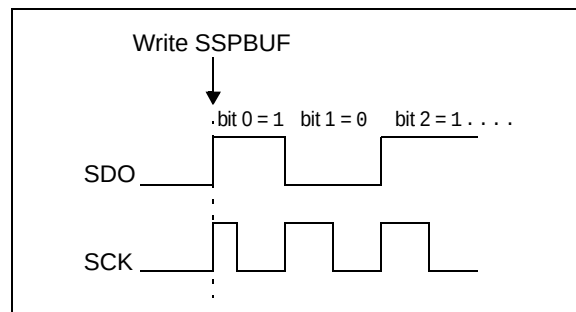
**FIGURE 1: SCK PULSE VARIATION USING TIMER2/2**

When the SPI is using Timer2/2 as the clock source, a shorter than expected SCK pulse may occur on the first bit of the transmitted/received data (Figure 1).

To avoid producing the short pulse, turn off Timer2 and clear the TMR2 register, load the SSPBUF with the data to transmit and then turn Timer2 back on. Refer to Example 6 for sample code.
