## PIC18F2515/2610/4515/4610 Rev. A4 Silicon Errata

The PIC18F2515/2610/4515/4610 Rev. A4 parts you have received conform functionally to the Device Data Sheet (DS39636D), except for the anomalies described below. Any Data Sheet Clarification issues related to the PIC18F2515/2610/4515/4610 will be reported in a separate Data Sheet errata. Please check the Microchip web site for any existing issues.

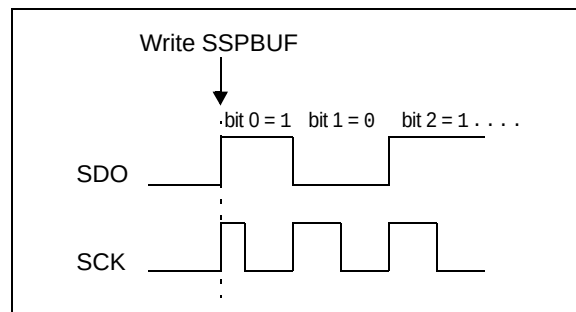
**FIGURE 1: SCK PULSE VARIATION USING TIMER2/2**

When the SPI is using Timer2/2 as the clock source, a shorter than expected SCK pulse may occur on the first bit of the transmitted/received data (Figure 1).

To avoid producing the short pulse, turn off Timer2 and clear the TMR2 register, load the SSPBUF with the data to transmit and then turn Timer2 back on. Refer to Example 6 for sample code.
