# PIC18F2525/2620/4525/4620

## PIC18F2525/2620/4525/4620 Rev. A3 Silicon Errata

The PIC18F2525/2620/4525/4620 Rev. A3 parts you have received conform functionally to the Device Data Sheet (DS39626), except for the anomalies described below. Any Data Sheet Clarification issues related to the PIC18F2525/2620/4525/4620 will be reported in a separate Data Sheet errata. Please check the Microchip web site for any existing issues.

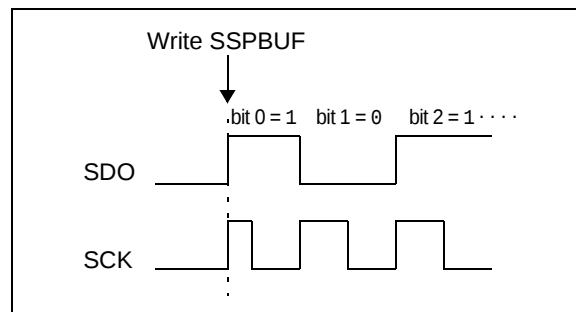
**FIGURE 1: SCK PULSE VARIATION USING TIMER2/2**

When the SPI is using Timer2/2 as the clock source, a shorter than expected SCK pulse may occur on the first bit of the transmitted/received data (Figure 1).

To avoid producing the short pulse, turn off Timer2 and clear the TMR2 register, load the SSPBUF with the data to transmit and then turn Timer2 back on. Refer to Example 5 for sample code.
