**MICROCHIP****PIC18F2525/2620/4525/4620****PIC18F2525/2620/4525/4620 Rev. A4 Silicon Errata**

The following silicon errata apply only to PIC18F2525/2620/4525/4620 devices with these Device/Revision IDs:

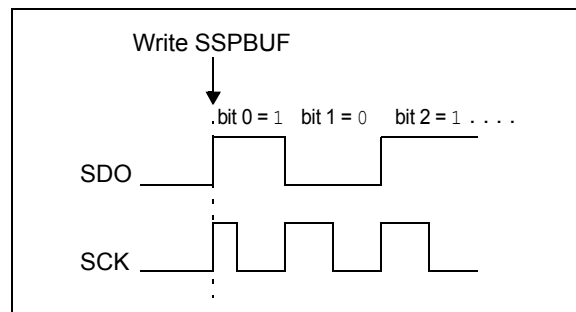
**FIGURE 1: SCK PULSE VARIATION USING TIMER2/2**

When the SPI is using Timer2/2 as the clock source, a shorter than expected SCK pulse may occur on the first bit of the transmitted/received data (Figure 1).

To avoid producing the short pulse, turn off Timer2 and clear the TMR2 register, load the SSPBUF with the data to transmit and then turn Timer2 back on. Refer to Example 5 for sample code.
