## PIC24FJ128GB204 Family Silicon Errata and Data Sheet Clarification

The PIC24FJ128GB204 family devices that you have received conform functionally to the current Device Data Sheet (DS30005009C), except for the anomalies described in this document.

# PIC24FJ128GB204 FAMILY

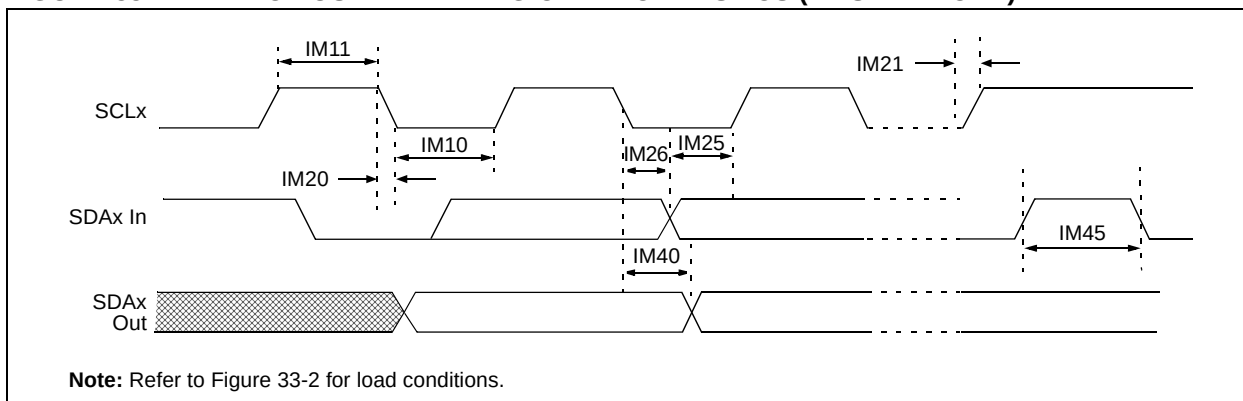
**FIGURE 33-14: I<sup>2</sup>C BUS DATA TIMING CHARACTERISTICS (MASTER MODE)**

Figure 33-14 and Figure 33-16 are modified as shown in the figures below.
