## PIC32MK General Purpose and Motor Control (GP/MC) Silicon Errata and Data Sheet Clarification

The PIC32MK General Purpose and Motor Control (GP/MC) family of devices that you have received conform functionally to the current Device Data Sheet (DS60001402F), except for the anomalies described in this document.

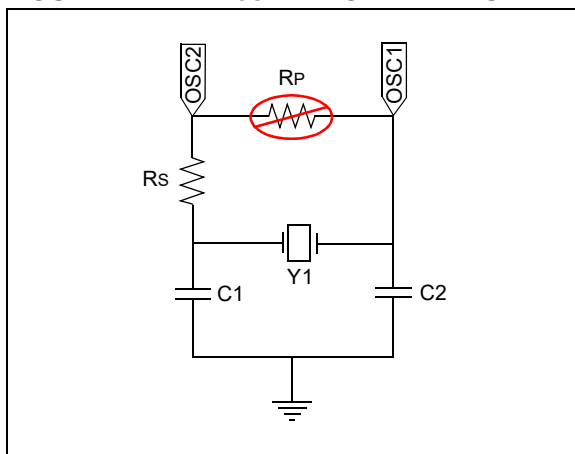
**FIGURE 1: POSC CRYSTAL CIRCUIT**

The POSC supports only specific crystal operation, as provided in [Table 1](#).

The Primary Oscillator (POSC) has been characterized to operate at 8 MHz and 12 MHz when the circuit shown in [Figure 1](#) is implemented and the operating conditions provided in [Table 1](#) are met.

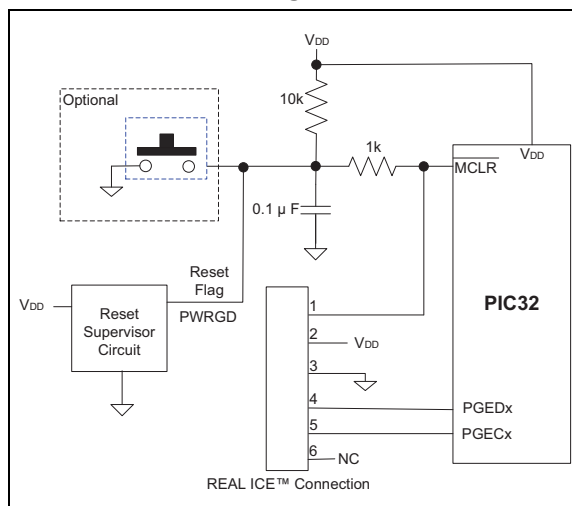
**FIGURE 2: RESET SUPERVISOR CIRCUIT**

On a BOR event,  $V_{POR} < V_{DD} < V_{BOR}$ , a Reset is not generated when the BOR threshold is reached. System clocks will stop with all I/O pins functions frozen in their present state until either  $V_{DD}$  falls to  $V_{POR}$  or  $V_{DD}$  returns to above  $V_{BOR}$ . The user must assess if this  $V_{DD}$  brown-out condition and the resulting frozen I/O pin state has an adverse effect on their application (UART, PWM, I/O, OC, etc.).

**Note:** For Motor Control applications utilizing the PWM module, **only Work around 1 is recommended.**

If the application can sustain frozen I/O states for ~2.1 ms (UART, CAN, I/O, etc.), the application must enable the Deep Sleep Watchdog Timer and Clock Fail Monitor, based on the details provided in Table 3 and Table 4. If implemented correctly, after ~2.1 ms, a valid internal reset state is entered and the I/O pins are set to the device default Reset state.
