### PIC32MX1XX/2XX/5XX 64/100-pin Family

### Silicon Errata and Data Sheet Clarification

The PIC32MX1XX/2XX/5XX 64/100-pin family devices that you have received conform functionally to the current Device Data Sheet (DS60001290F), except for the anomalies described in this document.

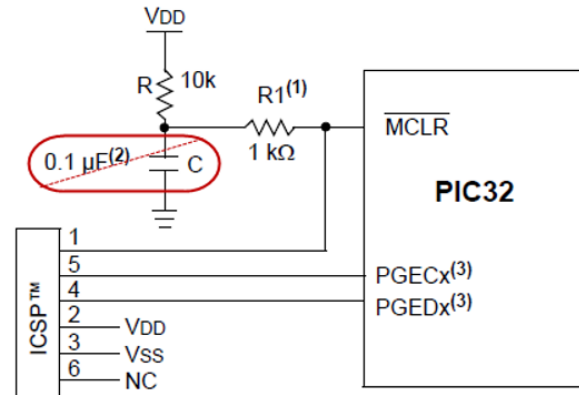
## 17. Module: I/O Port - Initial Pin State

On power-up depending on the VDD ramp rate, the I/O pins can be in an active random output driving state if MCLR is active until a BOR event.

If, not using an external reset supervisor IC or equivalent, remove the MCLR capacitor as shown below, and retain the MCLR Pull-up resistor.

If using an external reset supervisor IC or equivalent, increase the value of the VCAP capacitor to ≥47 µF ceramic or solid tantalum capacitor with an ESR ≤ 1 ohm.
