# PIC32MX534/564/664/764

## PIC32MX534/564/664/764 Family Silicon Errata and Data Sheet Clarification

The PIC32MX534/564/664/764 family devices that you have received conform functionally to the current Device Data Sheet (DS60001156K), except for the anomalies described in this document.

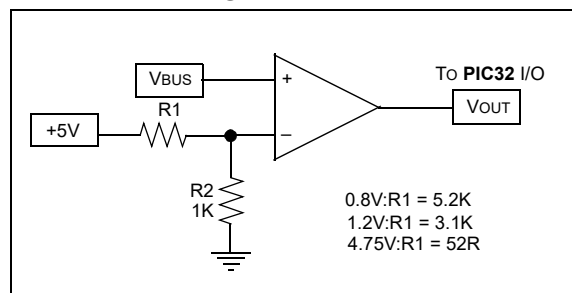
FIGURE 1: EXTERNAL COMPARATOR SCHEMATIC EXAMPLE

When the USB model is configured for OTG operation, it may not recognize all required OTG voltage levels on VBUS pin.

Use external comparator circuit to detect OTG specific voltage levels on VBUS pin.
