## PIC32MZ Embedded Connectivity (EC) Family Silicon Errata and Data Sheet Clarification

The PIC32MZ Embedded Connectivity (EC) family of devices that you have received conform functionally to the current Device Data Sheet (DS60001191D), except for the anomalies described in this document.

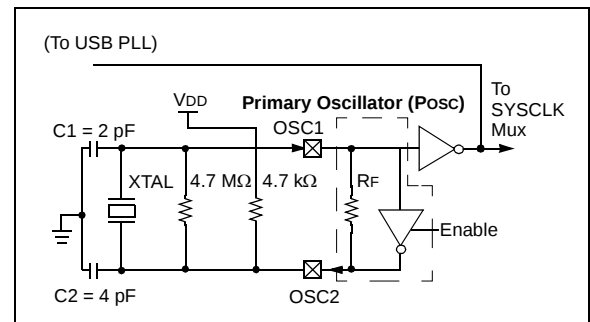
No other crystals are guaranteed to function 100% over voltage, temperature, and population. Adequate testing required in your application to ensure reliable operation.

The following figure shows the required configuration.
