## PIC32MZ Embedded Connectivity with Floating Point Unit (EF) Family Silicon Errata and Data Sheet Clarification

The PIC32MZ Embedded Connectivity with Floating Point Unit (EF) family of devices that you have received conform functionally to the current Device Data Sheet (DS60001320G), except for the anomalies described in this document.

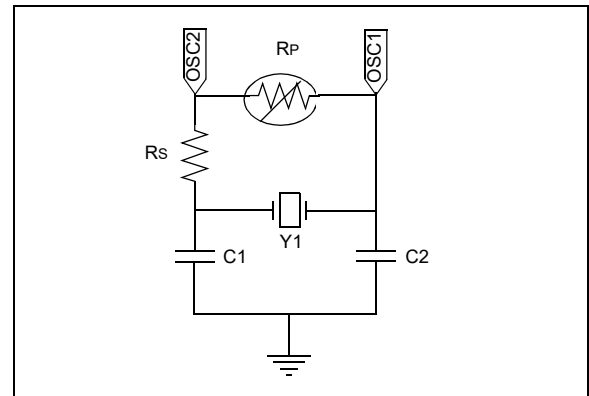
**FIGURE 1: Posc CRYSTAL CIRCUIT**

**Revision A1 Silicon:** A crystal oscillator cannot be used as an input to the Primary Oscillator (Posc) pins OSC1 and OSC2.

**Revision A3 and B2 Silicon:** The Posc has been tested in a normal power-up sequence and supports specific crystal operation.

The Primary Oscillator (Posc) has been characterized to operate at 8 MHz, 12 MHz, and 24 MHz when the circuit in [Figure 1](#) is implemented, and the operating conditions listed in [Table 3](#) are met.

**TABLE 3: CRYSTAL SPECIFICATIONS**

| Crystal Frequency<br>(see Note 1) | Series Resistor<br>(Rs) | Posc Gain Setting<br>POSCGAIN<1:0><br>(DEVCFG0<20:19>) | Posc Boost Setting<br>POSCBOOST<br>(DEVCFG0<21>) |
| 8 MHz | 2 kΩ | '0b00 (GAIN_0) | '0b1 (ON) |
| 12 MHz | 1 kΩ | '0b00 (GAIN_0) | '0b1 (ON) |
| 24 MHz | 0 kΩ | '0b00 (GAIN_0) | '0b1 (ON) |

- Note 1:** Using any other crystal frequency will require special component selection and characterization.
- Note 2:** A parallel resistor (Rp) should not be used to increase the gain of the POSC.
