# PIC32MZ Graphics (DA) Family

## PIC32MZ Graphics (DA) Family Silicon Errata and Data Sheet Clarification

The PIC32MZ Graphics (DA) family devices that you have received conform functionally to the current Device Data Sheet (DS60001361H), except for the anomalies described in this document.

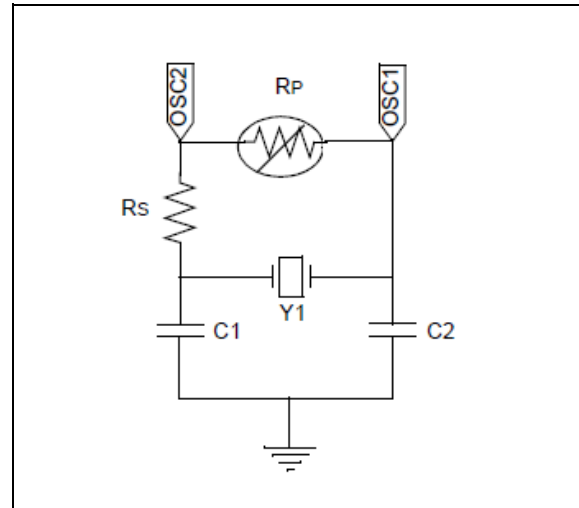
FIGURE 1: Posc CRYSTAL CIRCUIT

The POSC has been tested in a normal power-up sequence and supports specific crystal operation.

The Primary Oscillator (POSC) has been characterized to operate at 8 MHz and 12 MHz when the circuit shown in Figure 1 is implemented, and the operating conditions listed in Table 3 are met.

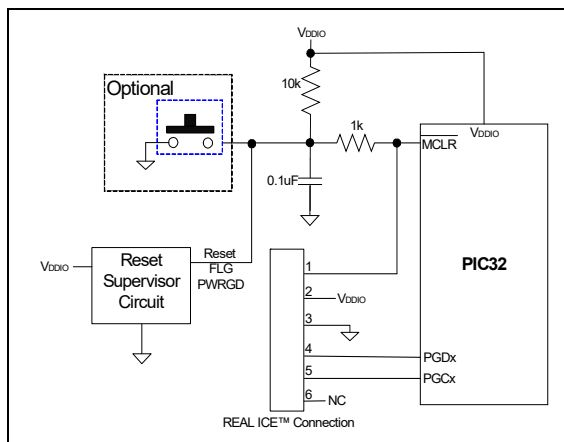
FIGURE 2: EXTERNAL RESET CIRCUIT

A system Reset is not generated on a BOR event ( $V_{PORIO} < V_{DDIO} < V_{BORIO}$ ). This will stop system clocks with all the I/O pin functions frozen in the present state until either  $V_{DDIO}$  falls to  $V_{PORIO}$  or  $V_{DDIO} > V_{BORIO}$ .

Reset device using a  $\overline{MCLR}$  pin through an external reset supervisor/monitor is shown in Figure 2. Set the SMCLR (DEVCFG2<15>) configuration bit to '0', which makes the  $\overline{MCLR}$  to act as a POR Reset instead of a normal system reset.

- Minimum Reset trip voltage of the external supervisor should be  $V_{BORIO} (Max) + 0.5V$ .
- The external reset supervisor/LDO output going to  $\overline{MCLR}$  should have an open drain output to not interfere with the MPLAB programming/debug tools.

When this work around is implemented, the minimum  $V_{DDIO}$  operating voltage of the application needs to be above the reset supervisor maximum trip voltage + 0.2V, where 0.2V compensates for variation in the external reset supervisor voltage.
