## SAM G55 Series Family Silicon Errata and Data Sheet Clarification

The SAM G55 Series family of devices that you have received conform functionally to the current Device Data Sheet (Atmel-11289F-ATARM-SAM-G55G-SAM-G55J-Datasheet\_27-May-16), except for the anomalies described in this document.

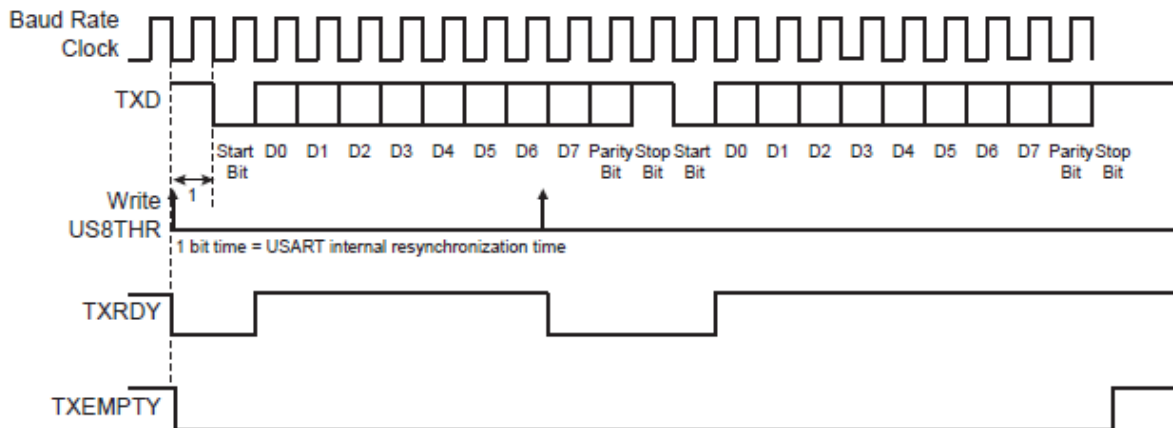
## 8. Module: USART - Transmitter Operations

Figure 30-6 is incorrect. The corrected figure is as shown below:
