## SCH3227/SCH3226/SCH3224/SCH3222

### Silicon Errata and Data Sheet Clarifications

## Silicon Errata Issues

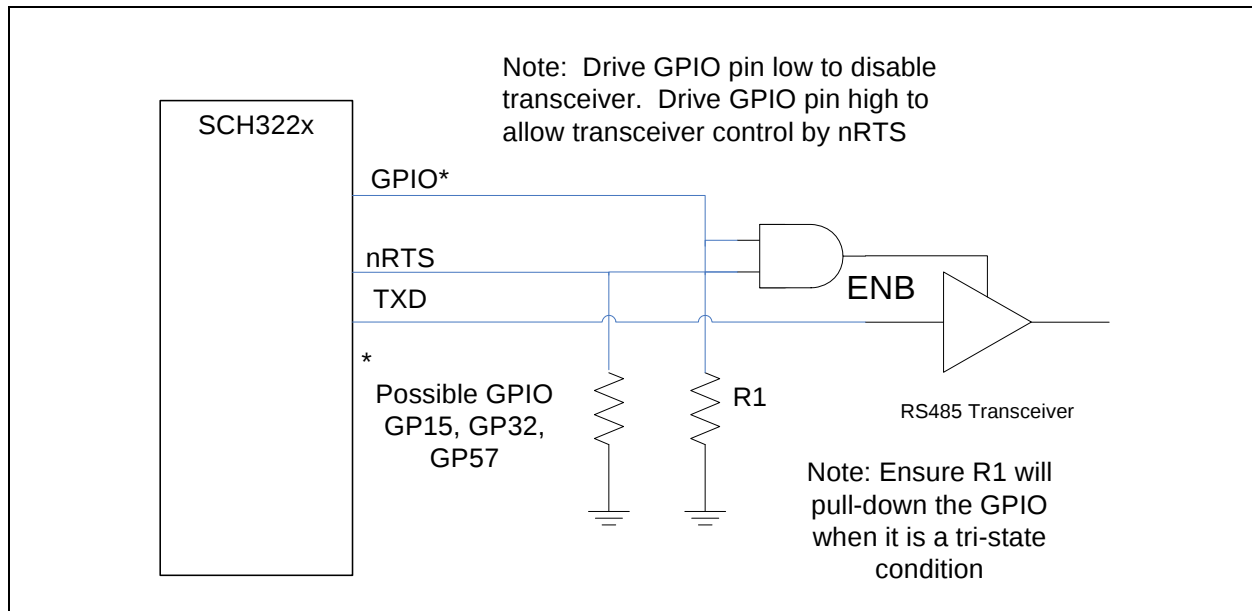
UART 3 and UART 4 do not tri-state their outputs on a PCI\_RESET as do UART 1 and UART 2.

UART 3 and UART 4 outputs are not controlled by the Configuration Register 0x30 ACTIVATE bit.

UART 3 and UART 4 outputs will drive High when PCI\_RESET goes active or when the ACTIVATE bit is cleared, and if the platform uses RTS to control an RS485 transceiver this may interrupt communication.

Use GPIO pin to disable RS485 transceiver when ACTIVATE bit is cleared.
