## ***TMS320F281x DSPs***

### ***Silicon Revisions G, F, E, D, C, B, A, 0***

This document describes the silicon updates to the functional specifications for the TMS320F2810, TMS320F2811, and TMS320F2812 digital signal processors (DSPs).

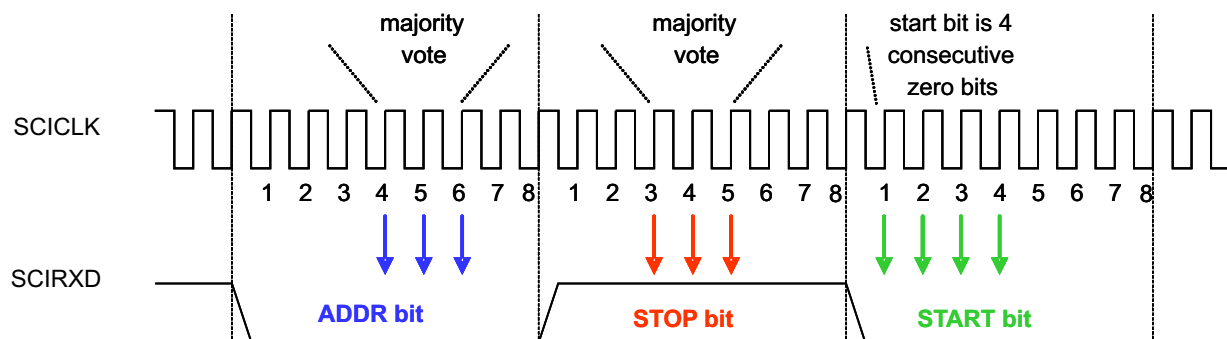
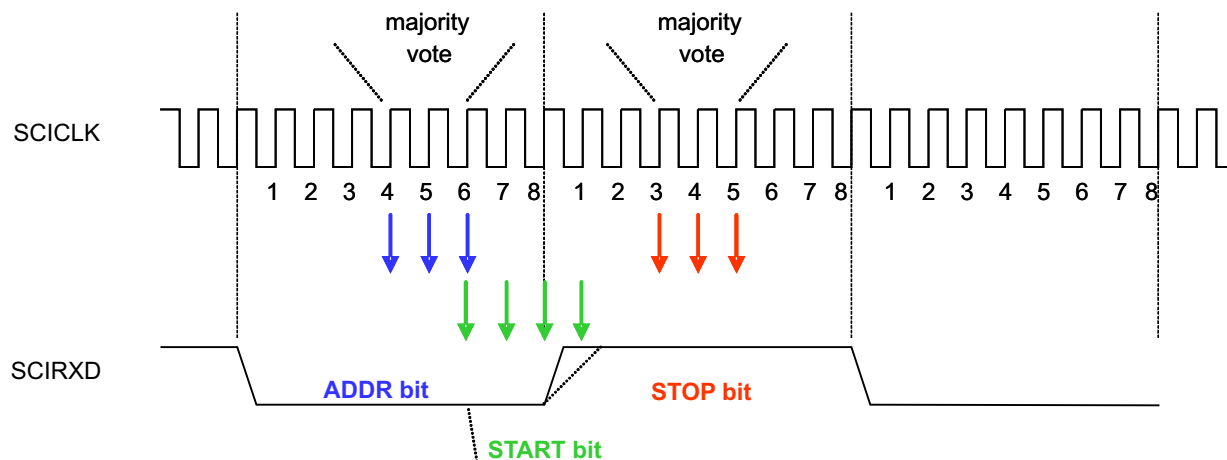
**Figure 3. Difference Between Expected and Erroneous Operation of START Bit**

The SCI does not look for the STOP bit after the ADDR bit. Instead, the SCI starts looking for the start bit beginning on sub-sample 6 of the ADDR bit. Slow rise time from the ADDR bit to the STOP bit can cause a false START bit to occur since the 4th sub-sample for the start bit may be sensed low.

Program the baud rate of the SCI to be slightly slower than the actual. This will cause the 4th sub-sample of the false START bit to be delayed in time, and therefore occur more towards the middle of the STOP bit (away from the signal transition region). The amount of baud-slowness needed depends on the rise time of the signal in the system. Alternatively, the IDLE mode of the SCI module may be used, if applicable.
