## Applicability

This document applies to the part numbers of STM32F031x4/x6 devices listed in [Table 1](#) and their variants shown in [Table 2](#).

[Section 1](#) gives a summary and [Section 2](#) a description of device limitations and documentation errata, with respect to the device datasheet and reference manual RM0091.

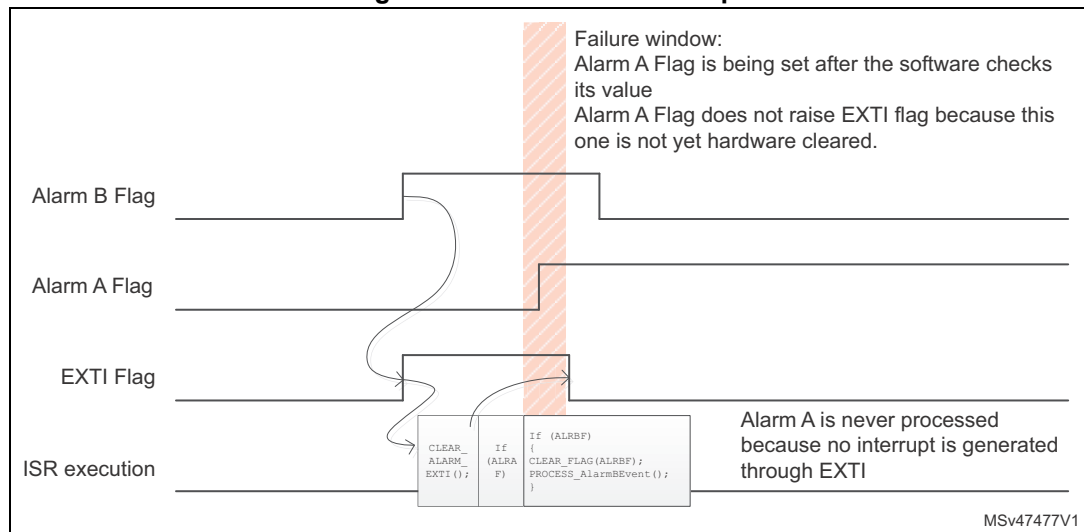
Figure 1. Masked RTC interrupt

The following code example and figure illustrate the failure mechanism: The Alarm A event is lost (fails to generate interrupt) as it occurs in the failure window, that is, after checking the Alarm A event flag but before the effective clear of the EXTI interrupt flag by hardware. The effective clear of the EXTI interrupt flag is delayed with respect to the software instruction to clear it.

In the interrupt service routine, apply three consecutive event flag checks - source one, source two, and source one again, as in the following code example:

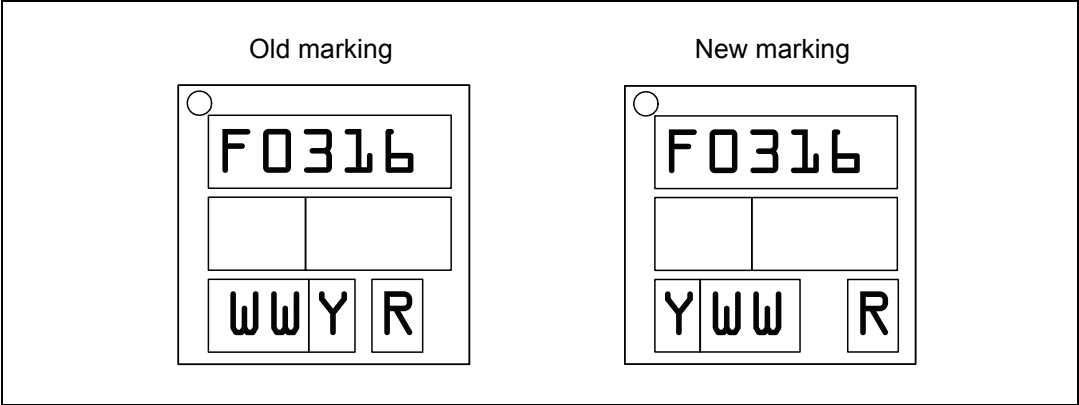
Figure 2. WLCSP25 package marking

From week 9, 2017 on, the marking on the WLCSP25 package is modified to show the date in the format YWW. [Figure 2](#) illustrates the difference between the old and the new product marking. The figure in the product datasheet was also updated to better reflect the dimensions and layout of the marking on the package.
