## Applicability

This document applies to the part numbers of STM32F051x4/x6/x8 devices listed in [Table 1](#) and their variants shown in [Table 2](#).

[Section 1](#) gives a summary and [Section 2](#) a description of device limitations and documentation errata, with respect to the device datasheet and reference manual RM0091.

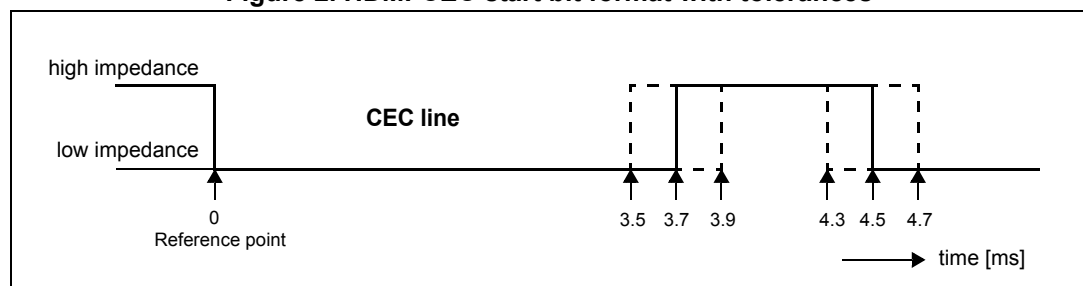
**Figure 2. HDMI-CEC start bit format with tolerances**

The start bit timing standard tolerances are shown in [Figure 2](#). The start bit is initiated by the device by driving the CEC line low (reference point). After 3.7 ms, the device releases the CEC line and starts checking its level. The following conditions must be met for the start bit to be valid:

If one of these conditions is not met, the transmission is aborted and never automatically retried. No error flag is set and the TXSOM (Tx Start Of Message) bit is not cleared.

The only way to detect this error is for the application software to start a timeout when setting the TXSOM bit, restart it upon ARBLST or any RX event (as the transmission can be delayed by interleaved reception), and stop it upon TXBR (proof that the start bit was transmitted successfully) or TXEND event, or upon any TX error (which clears TXSOM). If the timeout expires (because none of those events occurred), the application software must restart the HDMI-CEC peripheral and retransmit the message.
