## Applicability

This document applies to the STM32F058C8/R8 devices and their variants shown in [Table 1](#).

[Section 1](#) gives a summary and [Section 2](#) a description of device limitations and documentation errata, with respect to the device datasheet and reference manual RM0091.

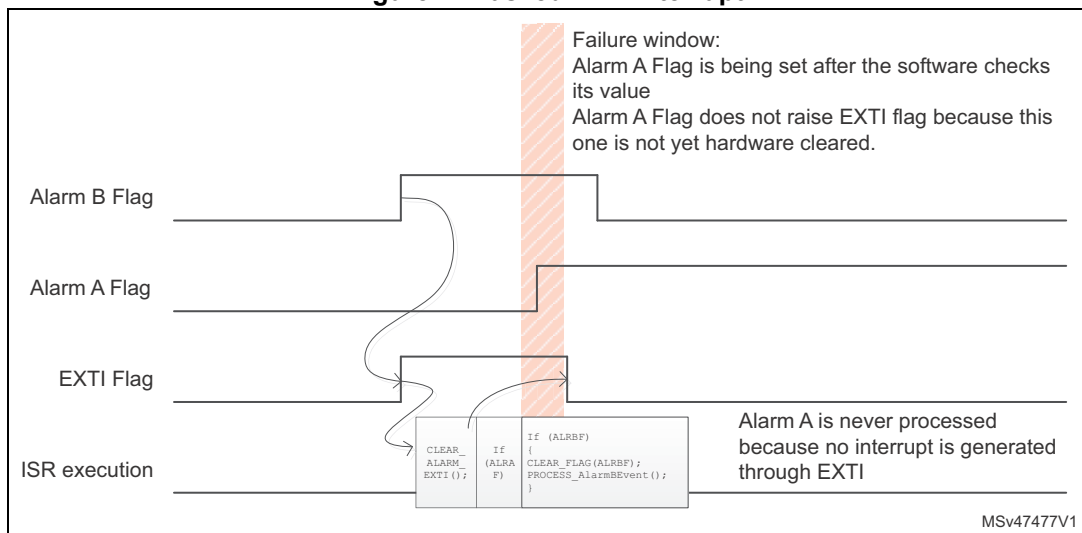
Figure 1. Masked RTC interrupt

The following code example and figure illustrate the failure mechanism: The Alarm A event is lost (fails to generate interrupt) as it occurs in the failure window, that is, after checking the Alarm A event flag but before the effective clear of the EXTI interrupt flag by hardware. The effective clear of the EXTI interrupt flag is delayed with respect to the software instruction to clear it.

In the interrupt service routine, apply three consecutive event flag checks - source one, source two, and source one again, as in the following code example:

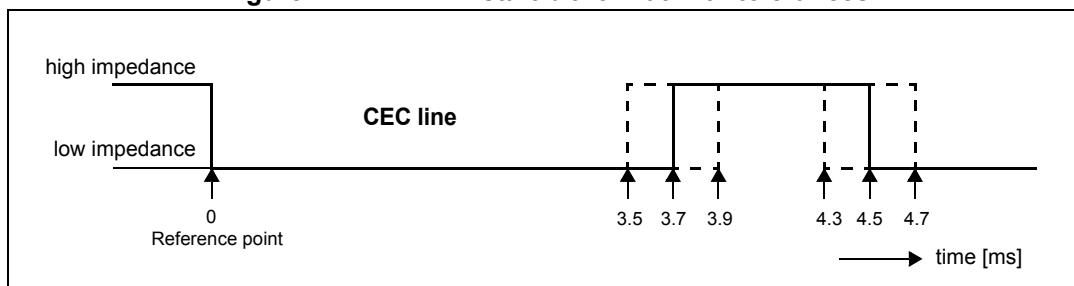
Figure 2. HDMI-CEC start bit format with tolerances

This failure is unlikely to happen as the CEC start bit corruption by another device can only occur if that device does not respect the CEC communication protocol.

The start bit timing standard tolerances are shown in [Figure 2](#). The start bit is initiated by the device by driving the CEC line low (reference point). After 3.7 ms, the device releases the CEC line and starts checking its level. The following conditions must be met for the start bit to be valid:

If one of these conditions is not met, the transmission is aborted and never automatically retried. No error flag is set and the TXSOM (Tx Start Of Message) bit is not cleared.

The only way to detect this error is for the application software to start a timeout when setting the TXSOM bit, restart it upon ARBLST or any RX event (as the transmission can be delayed by interleaved reception), and stop it upon TXBR (proof that the start bit was transmitted successfully) or TXEND event, or upon any TX error (which clears TXSOM). If the timeout expires (because none of those events occurred), the application software must restart the HDMI-CEC peripheral and retransmit the message.
