## Applicability

This document applies to the part numbers of STM32F070x6/xB devices listed in [Table 1](#) and their variants shown in [Table 2](#).

[Section 1](#) gives a summary and [Section 2](#) a description of device limitations and documentation errata, with respect to the device datasheet and reference manual RM0360.

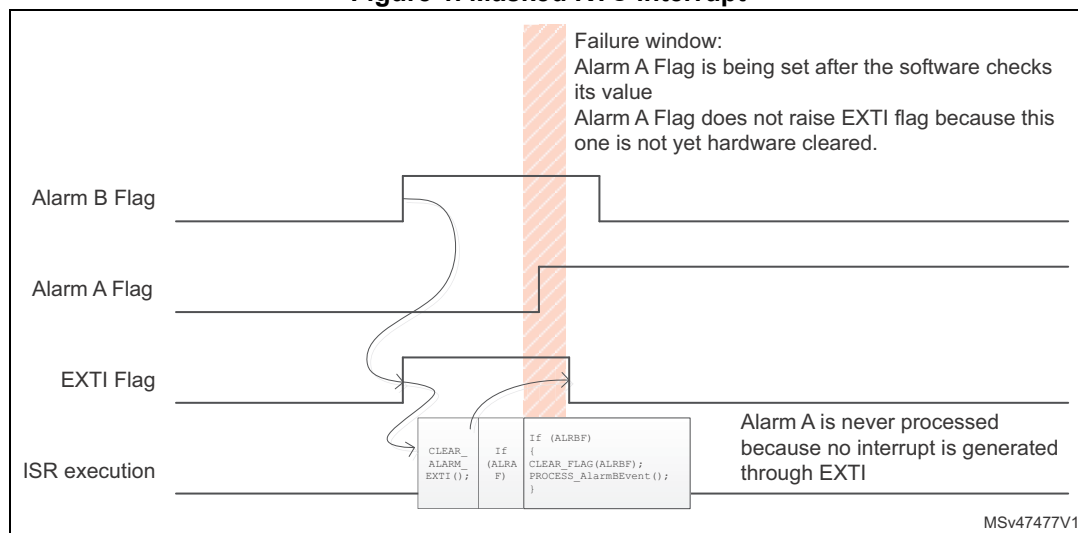
**Figure 1. Masked RTC interrupt**

One RTC interrupt can mask another RTC interrupt if both share the same EXTI configurable line, such as the RTC Alarm A and Alarm B, of which the event flags are OR-ed to the same EXTI line (refer to the **EXTI line connections** table in the **Extended interrupt and event controller (EXTI)** section of the reference manual).

The following code example and figure illustrate the failure mechanism: The Alarm A event is lost (fails to generate interrupt) as it occurs in the failure window, that is, after checking the Alarm A event flag but before the effective clear of the EXTI interrupt flag by hardware. The effective clear of the EXTI interrupt flag is delayed with respect to the software instruction to clear it.

In the interrupt service routine, apply three consecutive event flag checks - source one, source two, and source one again, as in the following code example:

```
void RTC_Alarm_IRQHandler(void)
{
    CLEAR_ALARM_EXTI(); /* Clear the EXTI's line Flag for RTC Alarm */
    If(ALRAF) /* Check if AlarmA triggered ISR */
    {
        CLEAR_FLAG(ALRAF); /* Clear the AlarmA interrupt pending bit */
        PROCESS_AlarmAEvent(); /* Process AlarmA Event */
    }
    If(ALRBF) /* Check if AlarmB triggered ISR */
    {
        CLEAR_FLAG(ALRBF); /* Clear the AlarmB interrupt pending bit */
        PROCESS_AlarmBEvent(); /* Process AlarmB Event */
    }
    If(ALRAF) /* Check if AlarmA triggered ISR */
    {
        CLEAR_FLAG(ALRAF); /* Clear the AlarmA interrupt pending bit */
        PROCESS_AlarmAEvent(); /* Process AlarmA Event */
    }
}
```
