## Applicability

This document applies to the part numbers of STM32F071x8/xB devices listed in [Table 1](#) and their variants shown in [Table 2](#).

# 1 Summary of device limitations

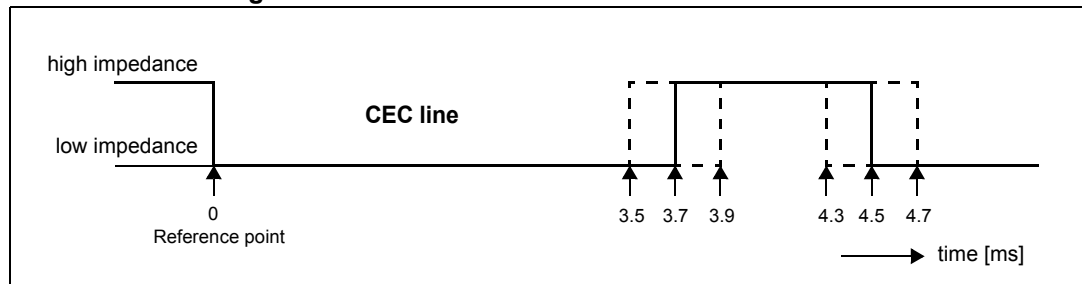
**Figure 1. HDMI-CEC start bit format with tolerances**

CEC line and starts checking its level. The following conditions must be met for the start bit to be valid:

If one of these conditions is not met, the transmission is aborted and never automatically retried. No error flag is set and the TXSOM (Tx Start Of Message) bit is not cleared.

The only way to detect this error is for the application software to start a timeout when setting the TXSOM bit, restart it upon ARBLST or any RX event (as the transmission can be delayed by interleaved reception), and stop it upon TXBR (proof that the start bit was transmitted successfully) or TXEND event, or upon any TX error (which clears TXSOM). If the timeout expires (because none of those events occurred), the application software must restart the HDMI-CEC peripheral and retransmit the message.
