## Applicability

This document applies to the part numbers of STM32F072x8/xB devices listed in [Table 1](#) and their variants shown in [Table 2](#).

**Table 1. Device summary**

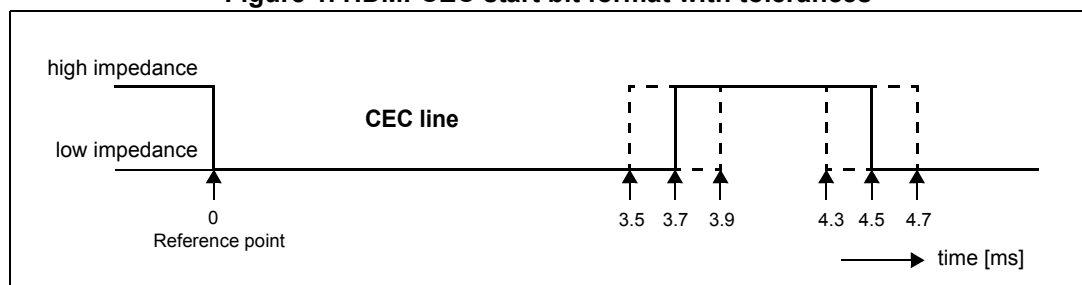
**Figure 1. HDMI-CEC start bit format with tolerances**

This failure is unlikely to happen as the CEC start bit corruption by another device can only occur if that device does not respect the CEC communication protocol.

The start bit timing standard tolerances are shown in [Figure 1](#). The start bit is initiated by the device by driving the CEC line low (reference point). After 3.7 ms, the device releases the CEC line and starts checking its level. The following conditions must be met for the start bit to be valid:

If one of these conditions is not met, the transmission is aborted and never automatically retried. No error flag is set and the TXSOM (Tx Start Of Message) bit is not cleared.

The only way to detect this error is for the application software to start a timeout when setting the TXSOM bit, restart it upon ARBLST or any RX event (as the transmission can be delayed by interleaved reception), and stop it upon TXBR (proof that the start bit was transmitted successfully) or TXEND event, or upon any TX error (which clears TXSOM). If the timeout expires (because none of those events occurred), the application software must restart the HDMI-CEC peripheral and retransmit the message.
