## Applicability

This document applies to the STM32F078CB/RB/VB devices and their variants shown in [Table 1](#).

[Section 1](#) gives a summary and [Section 2](#) a description of device limitations, with respect to the device datasheet and reference manual RM0091.

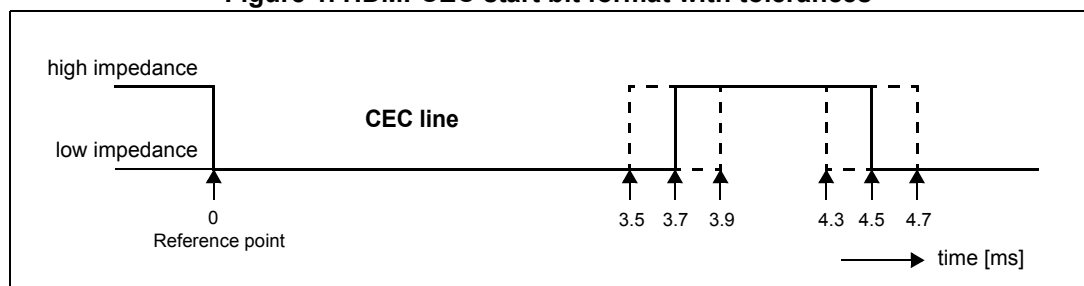
**Figure 1. HDMI-CEC start bit format with tolerances**

This failure is unlikely to happen as the CEC start bit corruption by another device can only occur if that device does not respect the CEC communication protocol.

The start bit timing standard tolerances are shown in [Figure 1](#). The start bit is initiated by the device by driving the CEC line low (reference point). After 3.7 ms, the device releases the CEC line and starts checking its level. The following conditions must be met for the start bit to be valid:

If one of these conditions is not met, the transmission is aborted and never automatically retried. No error flag is set and the TXSOM (Tx Start Of Message) bit is not cleared.

The only way to detect this error is for the application software to start a timeout when setting the TXSOM bit, restart it upon ARBLST or any RX event (as the transmission can be
