## Applicability

This document applies to the part numbers of STM32F091xB/xC devices listed in [Table 1](#) and their variants shown in [Table 2](#).

[Section 1](#) gives a summary and [Section 2](#) a description of device limitations and documentation errata, with respect to the device datasheet and reference manual RM0091.

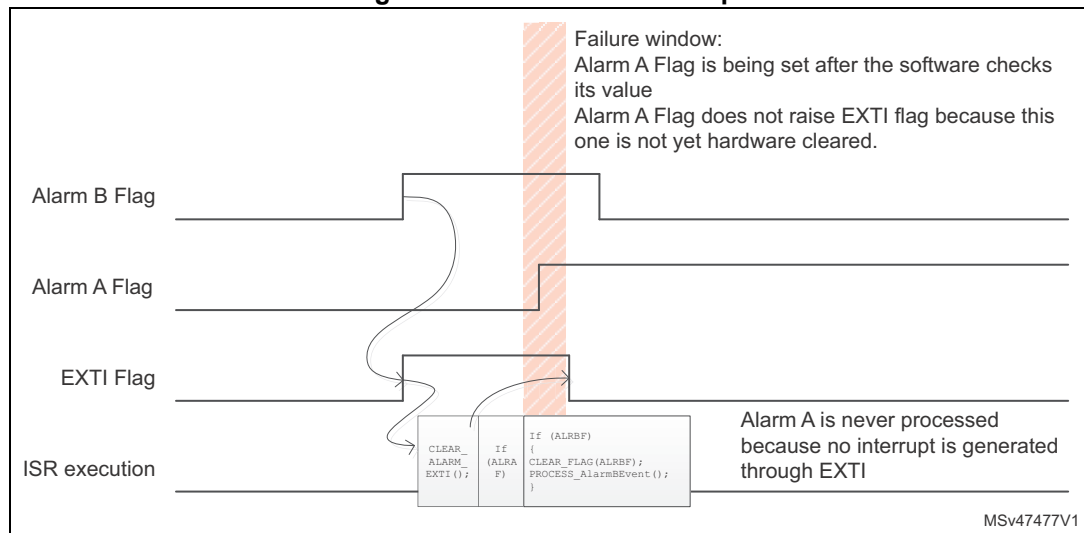
**Figure 1. Masked RTC interrupt**

## 2.7.4 RTC interrupt can be masked by another RTC interrupt

One RTC interrupt can mask another RTC interrupt if both share the same EXTI configurable line, such as the RTC Alarm A and Alarm B, of which the event flags are OR-ed to the same EXTI line (refer to the **EXTI line connections** table in the **Extended interrupt and event controller (EXTI)** section of the reference manual).

The following code example and figure illustrate the failure mechanism: The Alarm A event is lost (fails to generate interrupt) as it occurs in the failure window, that is, after checking the Alarm A event flag but before the effective clear of the EXTI interrupt flag by hardware. The effective clear of the EXTI interrupt flag is delayed with respect to the software instruction to clear it.

In the interrupt service routine, apply three consecutive event flag checks - source one, source two, and source one again, as in the following code example:

void RTC_Alarm_IRQHandler(void)
{
  CLEAR_ALARM_EXTI(); /* Clear the EXTI's line Flag for RTC Alarm */
  If(ALRAF) /* Check if AlarmA triggered ISR */
  {
    CLEAR_FLAG(ALRAF); /* Clear the AlarmA interrupt pending bit */
    PROCESS_AlarmAEvent(); /* Process AlarmA Event */
  }
  If(ALRBF) /* Check if AlarmB triggered ISR */
  {
    CLEAR_FLAG(ALRBF); /* Clear the AlarmB interrupt pending bit */
    PROCESS_AlarmBEvent(); /* Process AlarmB Event */
  }
  If(ALRAF) /* Check if AlarmA triggered ISR */
  {
    CLEAR_FLAG(ALRAF); /* Clear the AlarmA interrupt pending bit */
    PROCESS_AlarmAEvent(); /* Process AlarmA Event */
  }
}

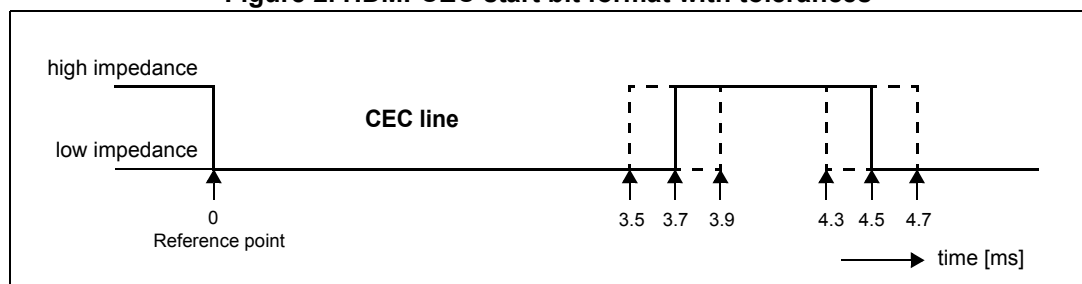
**Figure 2. HDMI-CEC start bit format with tolerances**

This failure is unlikely to happen as the CEC start bit corruption by another device can only occur if that device does not respect the CEC communication protocol.

The start bit timing standard tolerances are shown in [Figure 2](#). The start bit is initiated by the device by driving the CEC line low (reference point). After 3.7 ms, the device releases the CEC line and starts checking its level. The following conditions must be met for the start bit to be valid:

If one of these conditions is not met, the transmission is aborted and never automatically retried. No error flag is set and the TXSOM (Tx Start Of Message) bit is not cleared.

The only way to detect this error is for the application software to start a timeout when setting the TXSOM bit, restart it upon ARBLST or any RX event (as the transmission can be
