## Applicability

This document applies to the STM32F098CC/RC/VC devices and their variants shown in [Table 1](#).

[Section 1](#) gives a summary and [Section 2](#) a description of device limitations and documentation errata, with respect to the device datasheet and reference manual RM0091.

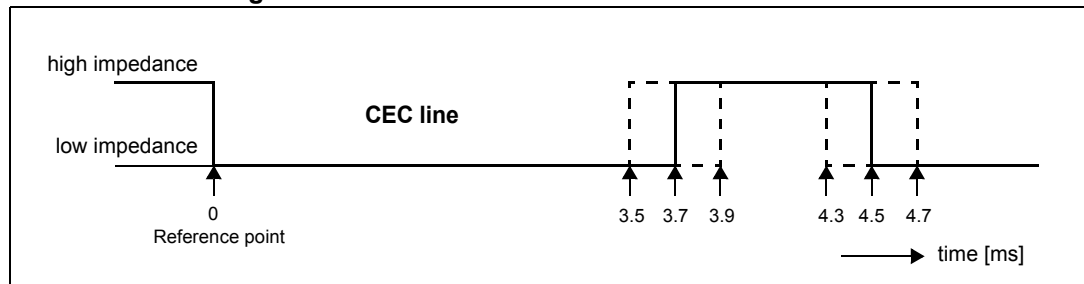
**Figure 2. HDMI-CEC start bit format with tolerances**

CEC line and starts checking its level. The following conditions must be met for the start bit to be valid:

If one of these conditions is not met, the transmission is aborted and never automatically retried. No error flag is set and the TXSOM (Tx Start Of Message) bit is not cleared.

### Workaround

The only way to detect this error is for the application software to start a timeout when setting the TXSOM bit, restart it upon ARBLST or any RX event (as the transmission can be delayed by interleaved reception), and stop it upon TXBR (proof that the start bit was transmitted successfully) or TXEND event, or upon any TX error (which clears TXSOM). If the timeout expires (because none of those events occurred), the application software must restart the HDMI-CEC peripheral and retransmit the message.
