## Silicon identification

This errata sheet applies to the revision A or 1 of the STMicroelectronics STM32F101xF/G access line and STM32F103xF/G performance line XL-density products. These families feature an Arm® 32-bit Cortex®-M3 core, for which an errata notice is also available (see [Section 1](#) for details).

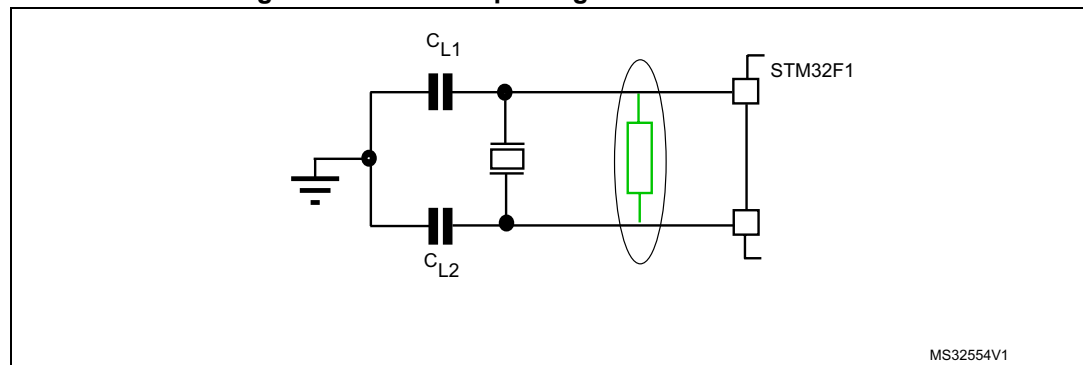
Figure 1. LSE start-up using an additional resistor

The LSE (Low Speed External) oscillator system has been designed to minimize the overall power consumption of the STM32F1 microcontroller. It is extremely important to take specific care in the design of the PCB to ensure this low power oscillator starts in harsh conditions. In some PCB designs without coating, an induced low leakage may prevent the LSE to start-up, regardless of the 32.768 KHz crystal used. This phenomenon is amplified in humid environments that create frost on the OSC32\_IN/OSC32\_OUT tracks. This unwanted behavior may happen only at the first back-up domain power-on of the device.

It is recommended to mount an additional parallel feedback resistor (from 16 MΩ to 22 MΩ) on board to help the oscillation start-up in all cases (see [Figure 1](#)). For more details on compatible crystals and hardware techniques on PCB, refer to AN2867 “Oscillator design guide for STM8AF/AL/S, STM32 MCUs and MPUs” available on [www.st.com](http://www.st.com).
