## STM32F105xx and STM32F107xx revision Z connectivity line device limitations

This errata sheet applies to the revision Z of the STMicroelectronics STM32F105xx and STM32F107xx connectivity line products. This family features an Arm® 32-bit Cortex®-M3 core, for which an errata notice is also available (see [Section 1](#) for details).

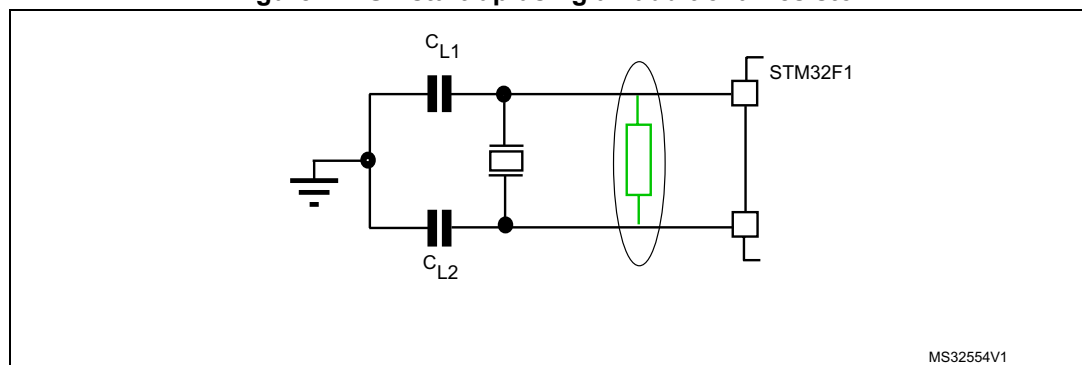
Figure 1. LSE start-up using an additional resistor

The LSE (Low Speed External) oscillator system has been designed to minimize the overall power consumption of the STM32F1 microcontroller. It is extremely important to take specific care in the design of the PCB to ensure this low power oscillator starts in harsh conditions. In some PCB designs without coating, an induced low leakage may prevent the LSE to start-up, regardless of the 32.768 KHz crystal used. This phenomenon is amplified in humid environments that create frost on the OSC32\_IN/OSC32\_OUT tracks. This unwanted behavior may happen only at the first back-up domain power-on of the device.

It is recommended to mount an additional parallel feedback resistor (from 16 M $\Omega$  to 22 M $\Omega$ ) on board to help the oscillation start-up in all cases (see [Figure 1](#)). For more details on compatible crystals and hardware techniques on PCB, refer to AN2867 application note.
