## STM32F302x6/x8 device errata

This document applies to the part numbers of STM32F302x6/x8 devices and the device variants as stated in this page.

It gives a summary and a description of the device errata, with respect to the device datasheet and reference manual RM0366.

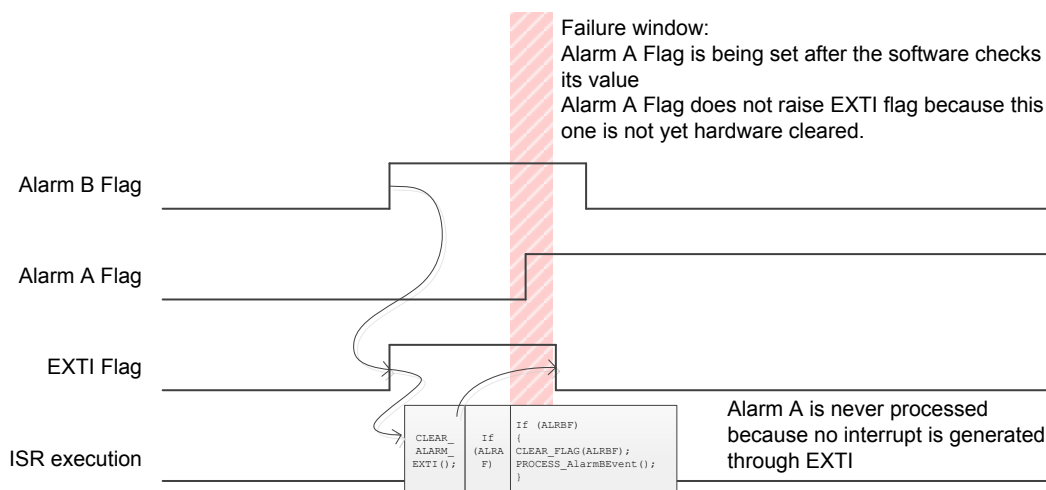
Figure 1. Masked RTC interrupt

The following code example and figure illustrate the failure mechanism: The Alarm A event is lost (fails to generate interrupt) as it occurs in the failure window, that is, after checking the Alarm A event flag but before the effective clear of the EXTI interrupt flag by hardware. The effective clear of the EXTI interrupt flag is delayed with respect to the software instruction to clear it.

In the interrupt service routine, apply three consecutive event flag checks - source one, source two, and source one again, as in the following code example:
