## STM32F318C8/K8 device errata

This document applies to the part numbers of STM32F318C8/K8 devices and the device variants as stated in this page.

It gives a summary and a description of the device errata, with respect to the device datasheet and reference manual RM0366.

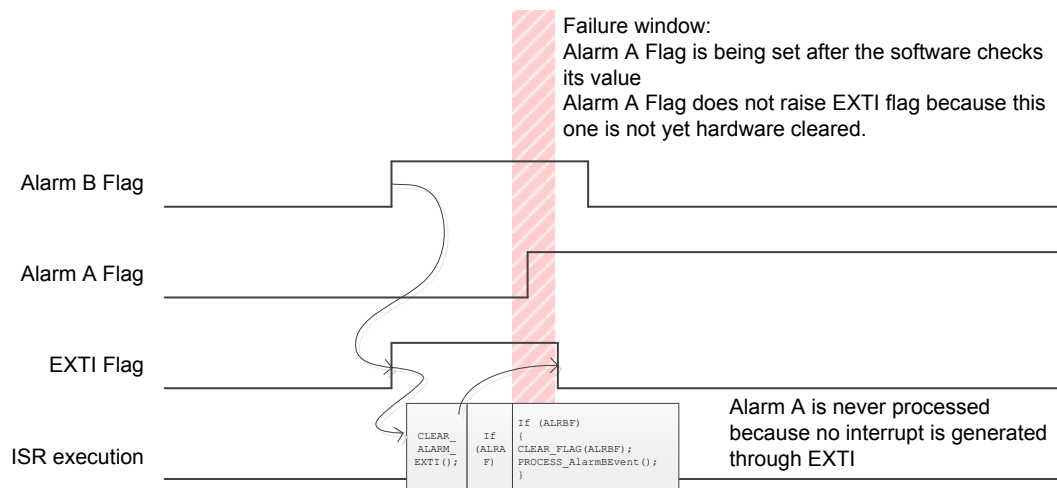
**Figure 1. Masked RTC interrupt**

The following code example and figure illustrate the failure mechanism: The Alarm A event is lost (fails to generate interrupt) as it occurs in the failure window, that is, after checking the Alarm A event flag but before the effective clear of the EXTI interrupt flag by hardware. The effective clear of the EXTI interrupt flag is delayed with respect to the software instruction to clear it.

In the interrupt service routine, apply three consecutive event flag checks - source one, source two, and source one again, as in the following code example:
