## Silicon identification

This errata sheet applies to the revision A, Z, Y and X of STMicroelectronics STM32L051x6/8 microcontrollers.

The STM32L051x6/8 devices feature an ARM® 32-bit Cortex®-M0+ core.

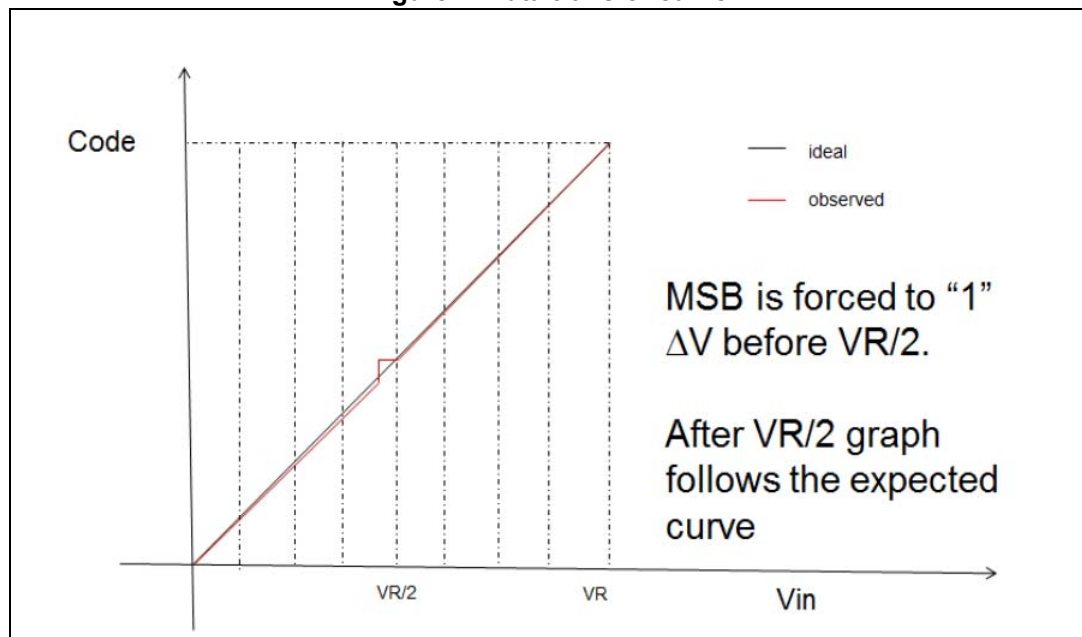
Figure 1. Data transfer curve

When  $V_{REF+}$  is lower than  $V_{DDA}$ , and only in this case, the data MSB is forced to '1' just before  $V_{IN}$  reaches  $V_{REF+}/2$ . As a result, the data transfer curve shows a discrepancy around  $V_{REF+}/2$  (see [Figure 1](#)).

*Note:* The transfer curve behaves as expected when  $V_{IN}$  is strictly lower or higher than  $V_{REF+}/2$ .
