### STM32L431xx device errata

This document applies to the part numbers of STM32L431xx devices and the device variants as stated in this page.

It gives a summary and a description of the device errata, with respect to the device datasheet and reference manual RM394.

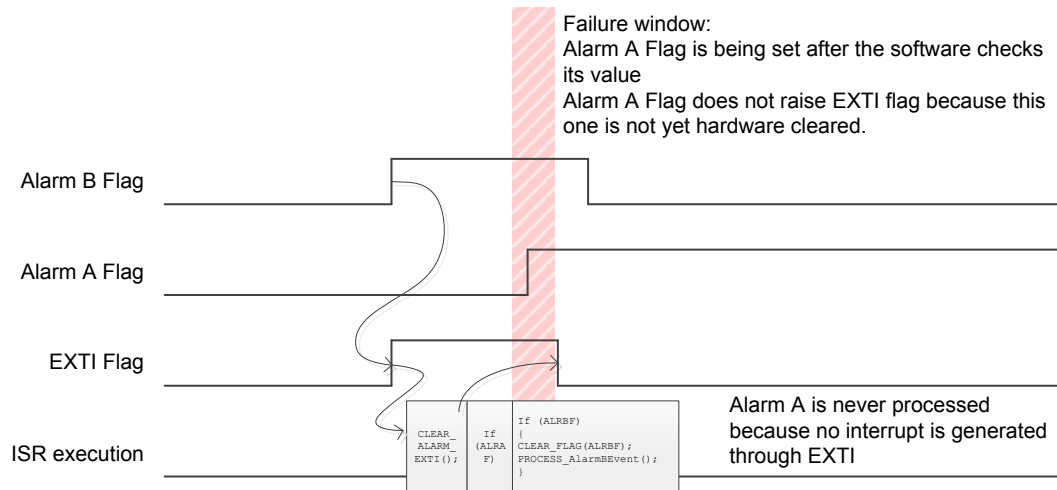
**Figure 1. Masked RTC interrupt**

The following code example and figure illustrate the failure mechanism: The Alarm A event is lost (fails to generate interrupt) as it occurs in the failure window, that is, after checking the Alarm A event flag but before the effective clear of the EXTI interrupt flag by hardware. The effective clear of the EXTI interrupt flag is delayed with respect to the software instruction to clear it.

In the interrupt service routine, apply three consecutive event flag checks - source one, source two, and source one again, as in the following code example:
