## Applicability

This document applies to the part numbers of STM32L471xx devices listed in [Table 1](#) and their variants shown in [Table 2](#).

[Section 1](#) gives a summary and [Section 2](#) a description of workarounds for device limitations, with respect to the device datasheet and reference manual RM0351.

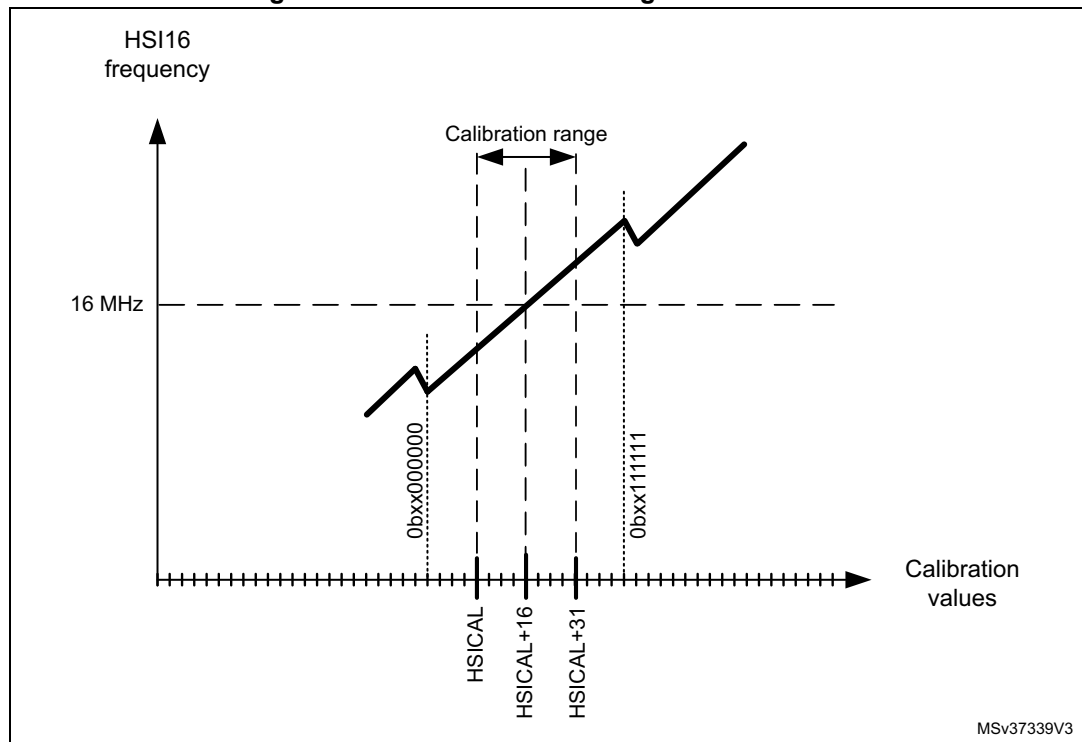
Figure 1. HSI oscillator trimming characteristics

Consequently, the user trim correction must not jump over the codes multiple of 64, which can limit the user correction either in positive or in negative direction.

**Workaround**

None.

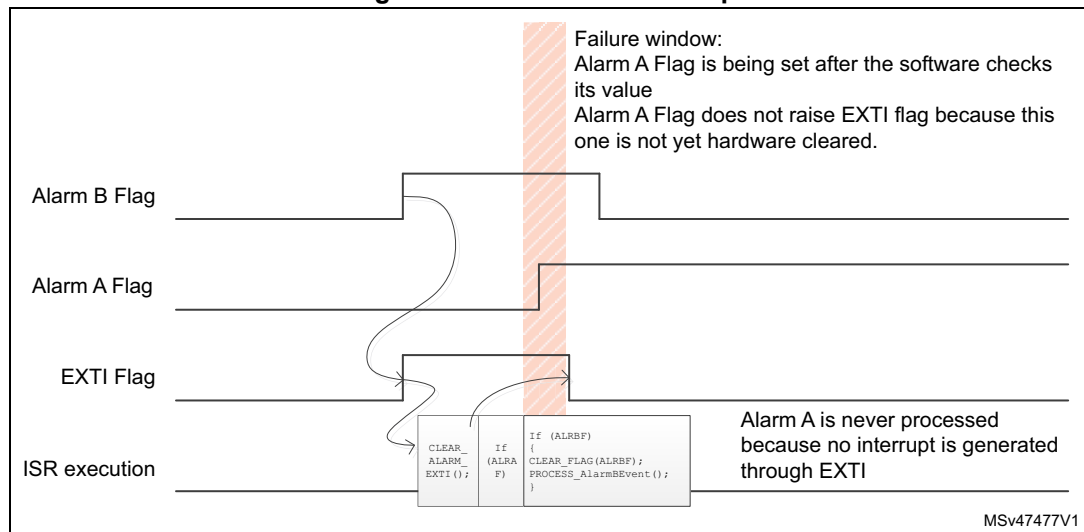
Figure 3. Masked RTC interrupt

The following code example and figure illustrate the failure mechanism: The Alarm A event is lost (fails to generate interrupt) as it occurs in the failure window, that is, after checking the Alarm A event flag but before the effective clear of the EXTI interrupt flag by hardware. The effective clear of the EXTI interrupt flag is delayed with respect to the software instruction to clear it.

### Workaround

In the interrupt service routine, apply three consecutive event flag checks - source one, source two, and source one again, as in the following code example:
