## Applicability

This document applies to the part numbers of STM32L475xx devices listed in [Table 1](#) and their variants shown in [Table 2](#).

**Table 1. Device summary**

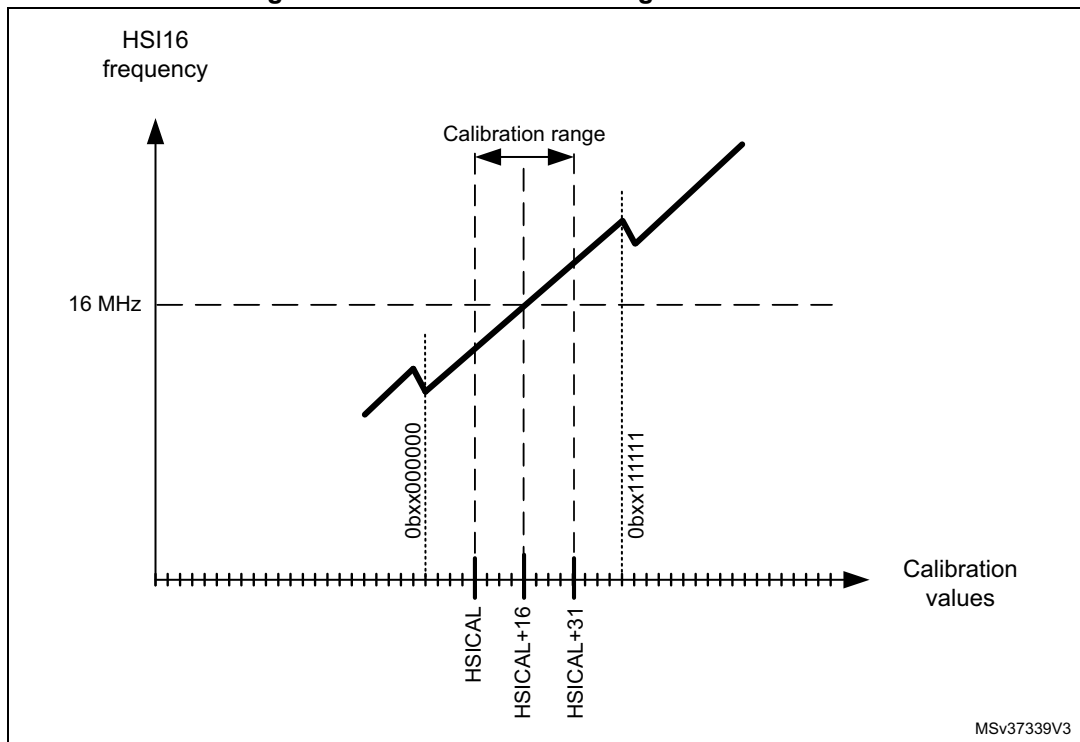
Figure 1. HSI oscillator trimming characteristics

Consequently, the user trim correction must not jump over the codes multiple of 64, which can limit the user correction either in positive or in negative direction.

### Workaround

None.

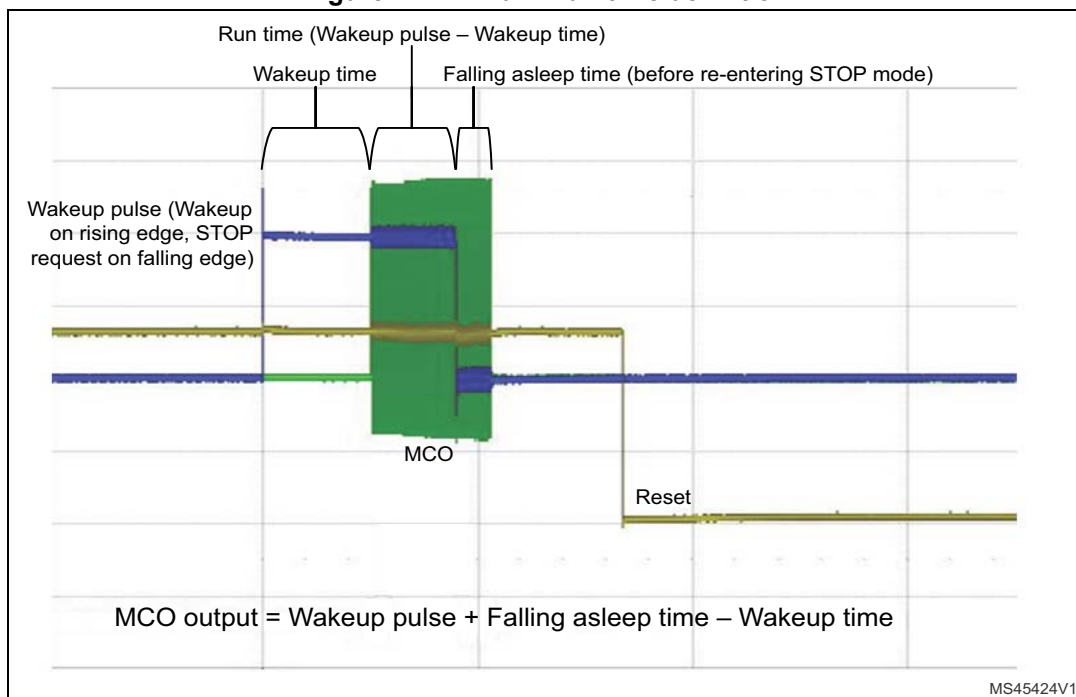
**Figure 2. Minimum Run time definition**

The minimum Run time defined in [Table 4](#) corresponds to the firmware execution time on the core. Note also that, as shown in [Figure 2](#), the length of the MCO output (green trace) is longer than the firmware execution time.

Ensure that the Run time between two Stop sequences is long enough to avoid the generation of a Brown Out Reset.
