## Applicability

This document applies to the part numbers of STM32L476xx and STM32L486xx devices listed in [Table 1](#) and their variants shown in [Table 2](#).

[Section 1](#) gives a summary and [Section 2](#) a description of workarounds for device limitations, with respect to the device datasheet and reference manual RM0351.

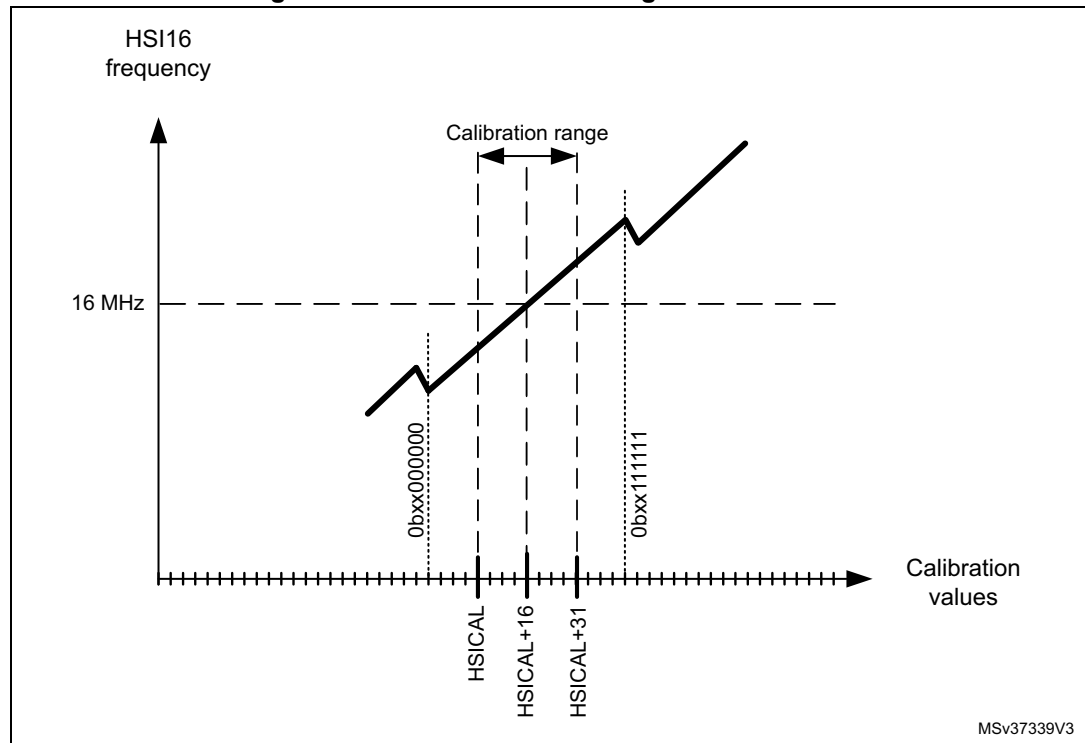
**Figure 1. HSI oscillator trimming characteristics**

Consequently, the user trim correction must not jump over the codes multiple of 64, which can limit the user correction either in positive or in negative direction.

None.

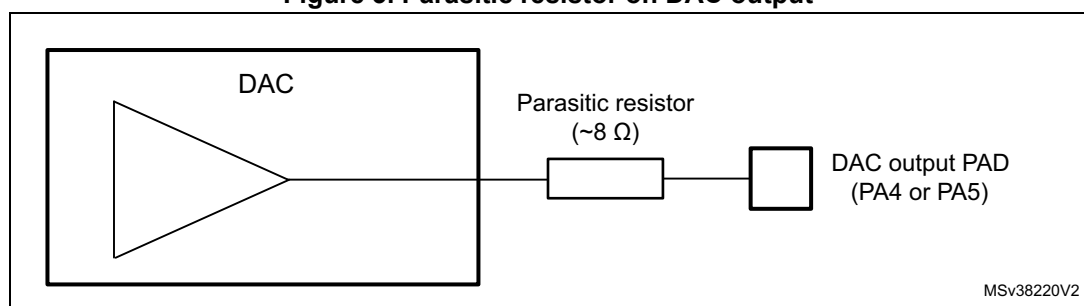
**Figure 3. Parasitic resistor on DAC output**

Resistor value between DAC outputs and I/O ( PA4 or PA5 ) is greater than expected: 8  $\Omega$  typical, as shown in [Figure 3](#). As a consequence, the DAC characteristics can be impacted depending on the current sunk on DAC output.

None.

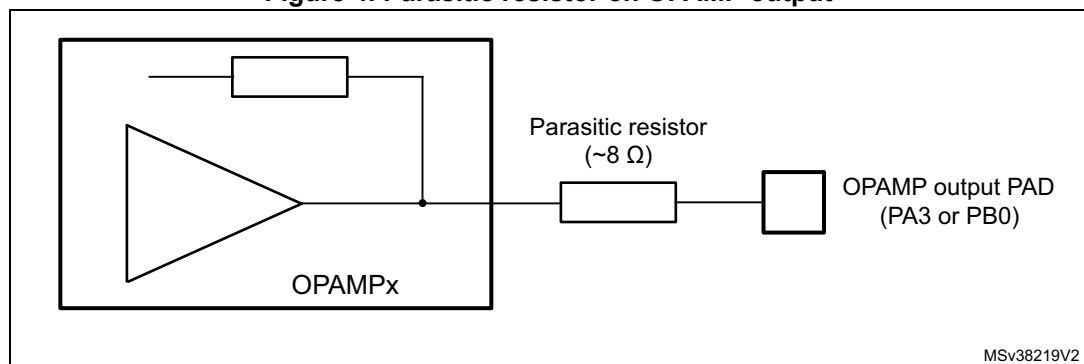
Figure 4. Parasitic resistor on OPAMP output

Resistor value between OPAMP outputs and I/O ( PA3 or PB0 ) is greater than expected: 8  $\Omega$  typical, as shown in [Figure 4](#). As a consequence the OPAMP characteristics can be impacted depending on the current sunk on the output.

None.

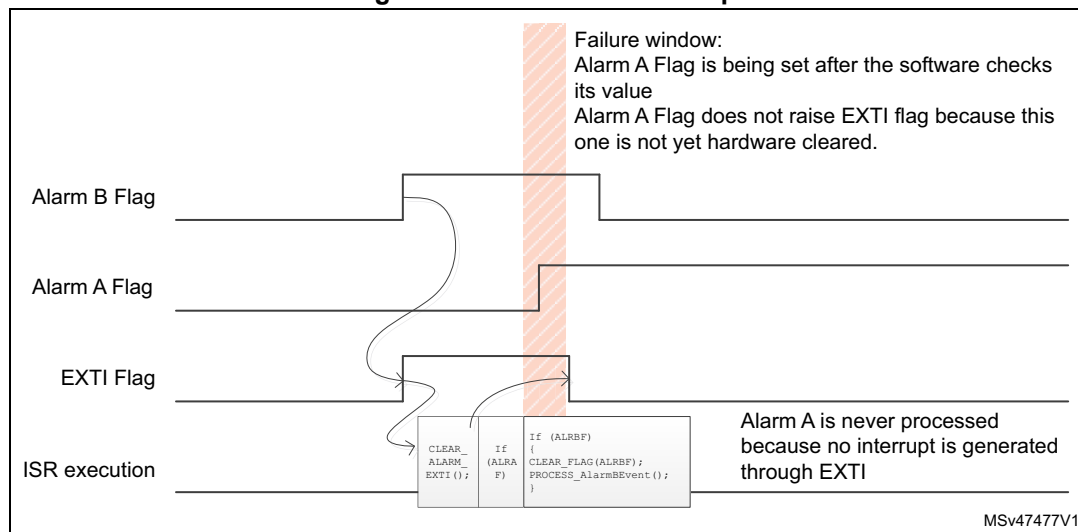
**Figure 5. Masked RTC interrupt**

The following code example and figure illustrate the failure mechanism: The Alarm A event is lost (fails to generate interrupt) as it occurs in the failure window, that is, after checking the Alarm A event flag but before the effective clear of the EXTI interrupt flag by hardware. The effective clear of the EXTI interrupt flag is delayed with respect to the software instruction to clear it.

In the interrupt service routine, apply three consecutive event flag checks - source one, source two, and source one again, as in the following code example:
