## Device limitations for STM8AFx2xx automotive MCUs featuring up to 128 Kbytes of Flash program memory

This errata sheet applies to the STMicroelectronics STM8AF526x/8x/Ax and STM8AF6269/8x/Ax devices. The full list of part numbers is given in [Table 2](#).

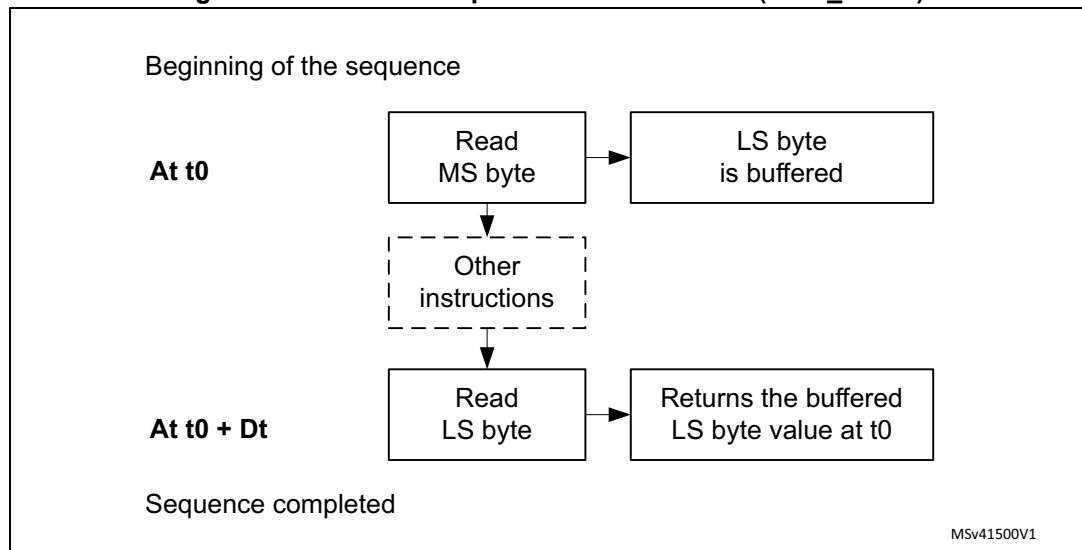
**Figure 1. 16-bit read sequence for the counter (TIMx\_CNTR)**

An 8-bit buffer is implemented for reading the 16-bit counter registers. Software must read the MS byte first, after which the LS byte value is buffered automatically (see [Figure 1](#)). This buffered value remains unchanged until the 16-bit read sequence is completed.

When any multi-cycle instruction precedes the read of the LSB, the content of the buffer is lost and the second read returns the immediate content of the counter directly.

Do not use multi-cycle instructions before reading the LSB.
