## Device limitations for STM8AFx2xx automotive MCUs featuring up to 128 Kbytes of Flash program memory

### Silicon identification

This errata sheet applies to the STMicroelectronics STM8AF526x/8x/Ax and STM8AF6269/8x/Ax devices. The full list of part numbers is given in [Table 2](#).

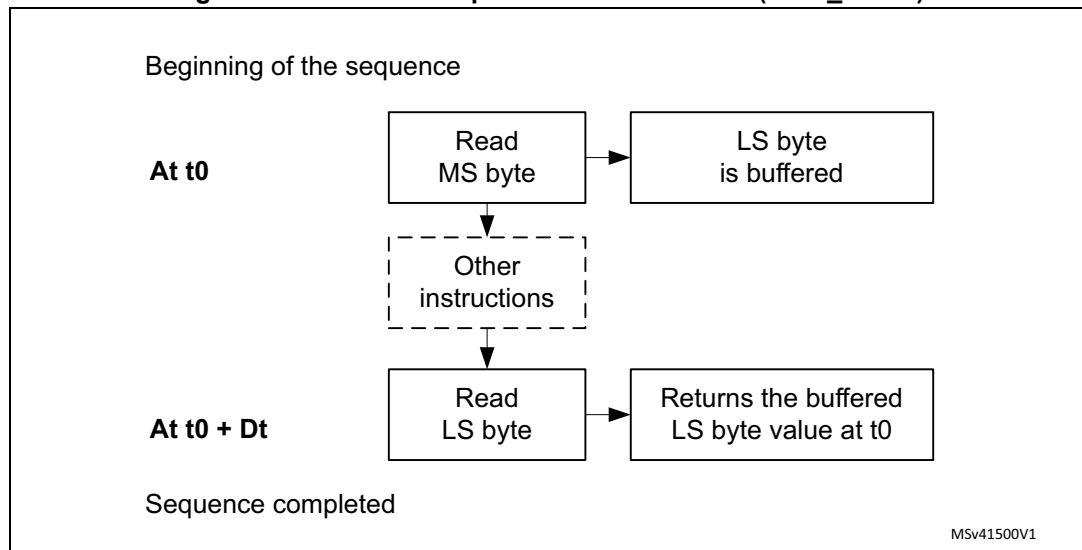
**Figure 1. 16-bit read sequence for the counter (TIMx\_CNTR)**

An 8-bit buffer is implemented for reading the 16-bit counter registers. Software must read the MS byte first, after which the LS byte value is buffered automatically (see [Figure 1](#)). This buffered value remains unchanged until the 16-bit read sequence is completed.

When any multi-cycle instruction precedes the read of the LSB, the content of the buffer is lost and the second read returns the immediate content of the counter directly.

Do not use multi-cycle instructions before reading the LSB.
