### Device limitations for STM8AF62xx automotive MCUs featuring up to 8 Kbytes of Flash program memory

This errata sheet applies to the STMicroelectronics STM8AF6213 and STM8AF6223/26 devices.

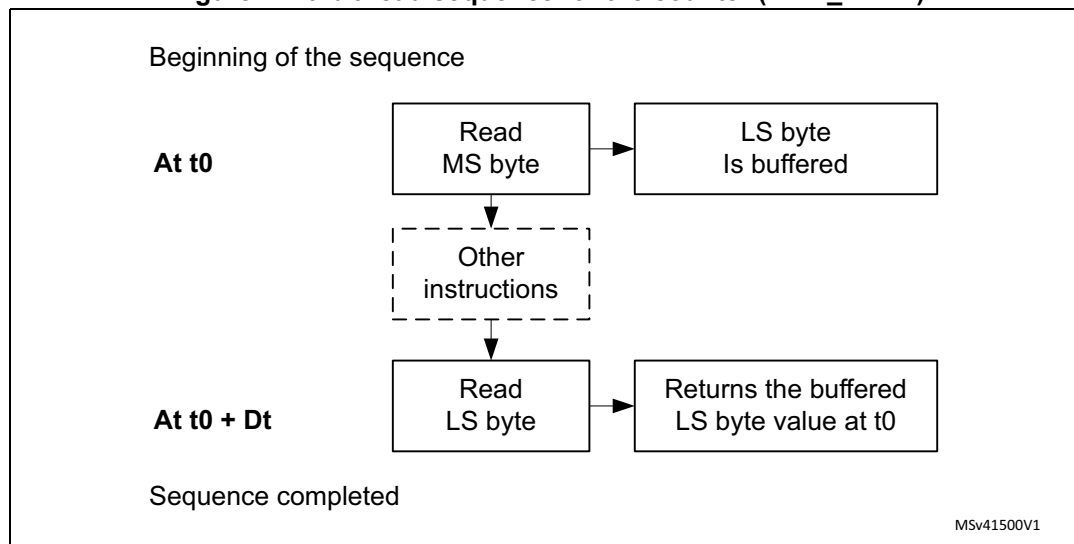
**Figure 1. 16-bit read sequence for the counter (TIMx\_CNTR)**

An 8-bit buffer is implemented for reading the 16-bit counter registers. Software must read the MS byte first, after which the LS byte value is buffered automatically (see [Figure 1](#)). This buffered value remains unchanged until the 16-bit read sequence is completed.

When any multi-cycle instruction precedes the read of the LSB, the content of the buffer is lost and the second read returns the immediate content of the counter directly.

Do not use multi-cycle instructions before reading the LSB.
