### Device limitations for STM8AF62xx automotive MCUs featuring up to 32 Kbytes of Flash program memory

#### Silicon identification

This errata sheet applies to the STMicroelectronics STM8AF624x and STM8AF626x devices. The full list of root part numbers is given in [Table 2](#).

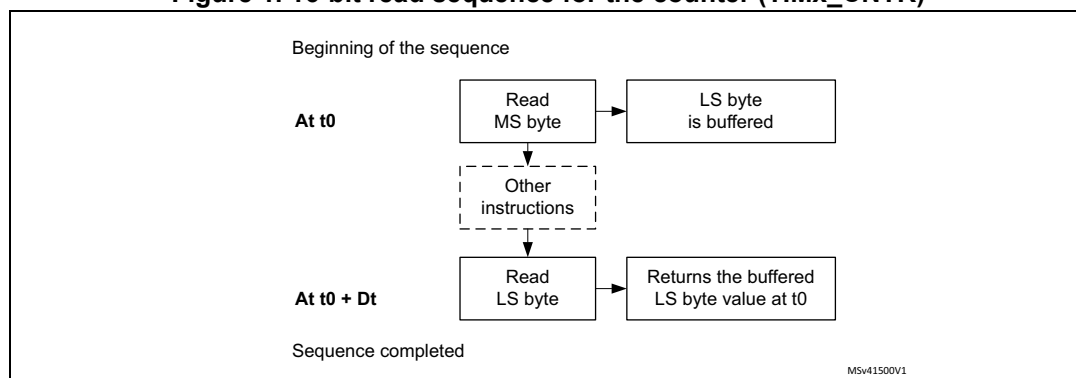
**Figure 1. 16-bit read sequence for the counter (TIMx\_CNTR)**

An 8-bit buffer is implemented for reading the 16-bit counter registers. Software must read the MS byte first, after which the LS byte value is buffered automatically (see [Figure 1](#)). This buffered value remains unchanged until the 16-bit read sequence is completed.

When any multi-cycle instruction precedes the read of the LSB, the content of the buffer is lost and the second read returns the immediate content of the counter directly.

Do not use multi-cycle instructions before reading the LSB.
