### STM8S001J3, STM8S003xx, STM8S103xx and STM8S903xx device limitations

This errata sheet applies to the STMicroelectronics STM8S001J3, STM8S003xx, STM8S103xx and STM8S903xx devices.

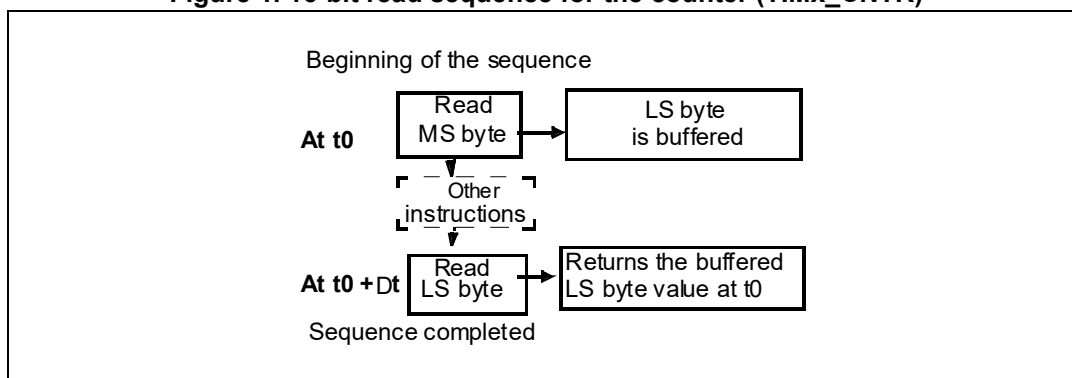
Figure 1. 16-bit read sequence for the counter (TIMx\_CNTR)

An 8-bit buffer is implemented for reading the 16-bit counter registers. Software must read the MS byte first, after which the LS byte value is buffered automatically (see [Figure 1](#)). This buffered value remains unchanged until the 16-bit read sequence is completed.

When any multi-cycle instruction precedes the read of the LSB, the content of the buffer is lost and the second read returns the immediate content of the counter directly.

Do not use multi-cycle instructions before reading the LSB.
