## STM32L432KB/KC and STM32L442KC device errata

This document applies to the part numbers of STM32L432KB/KC and STM32L442KC devices and the device variants as stated in this page.

It gives a summary and a description of the device errata, with respect to the device datasheet and reference manual RM394.

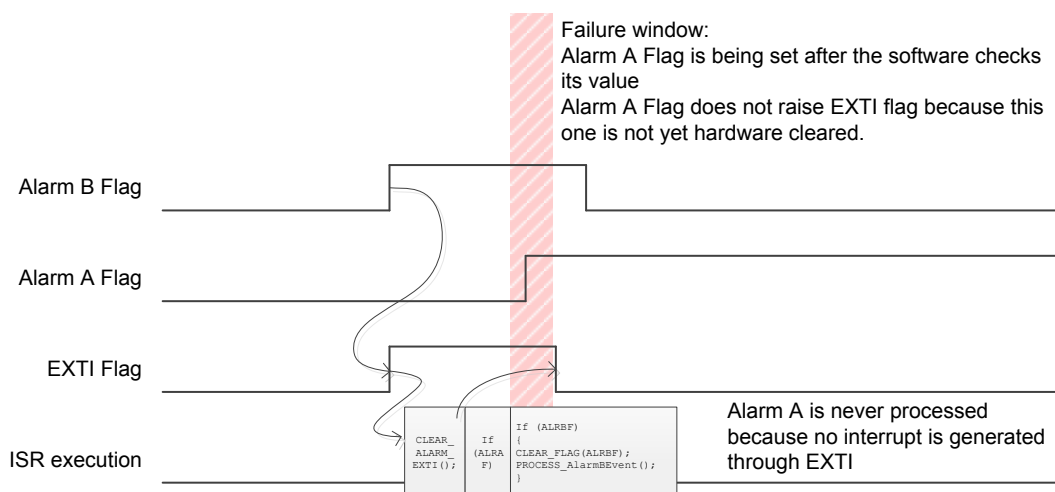
**Figure 1. Masked RTC interrupt**

The following code example and figure illustrate the failure mechanism: The Alarm A event is lost (fails to generate interrupt) as it occurs in the failure window, that is, after checking the Alarm A event flag but before the effective clear of the EXTI interrupt flag by hardware. The effective clear of the EXTI interrupt flag is delayed with respect to the software instruction to clear it.

In the interrupt service routine, apply three consecutive event flag checks - source one, source two, and source one again, as in the following code example:
