## Active Errata List

## CAN Microcontrollers

**T89C51CC01**  
**T89C51CC01UA**  
**T89C51CC01CA**

## Errata Sheet

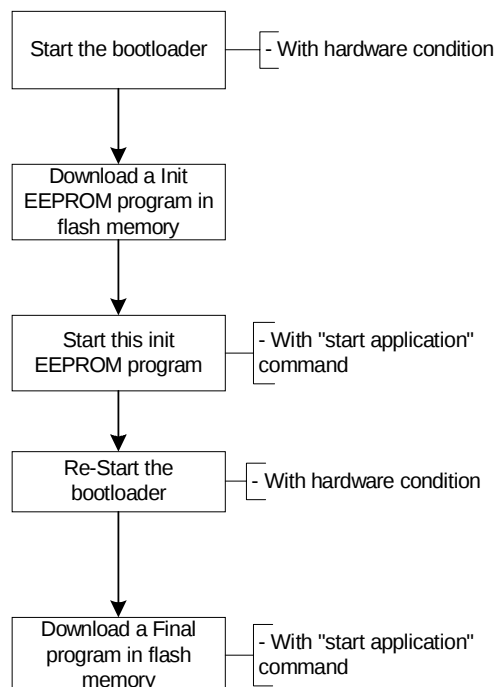
## 16. EEPROM – Lock-up during ISP write

Program lock-up can be experienced when using Atmel FLIP software or a custom In system Programming tools to write in the internal EEPROM. This problem occurs with clock frequency > 12MHz in X2 mode or 24MHz in X1 mode. Neither the code Flash nor the EEPROM are corrupted by the lock-up. Although the EEPROM cannot be written by the bootloader.

This problem is bootloader related and doesn't affect the capability for the user to read and write into the EEPROM. This problem is technology dependant. The likelihood of experiencing the problem is low at Clock frequency > 24 MHz in X1 mode and non-existent below. A reset can be applied to recover from the lock-up.

### Workaround

The following process can be done to work around the problem.

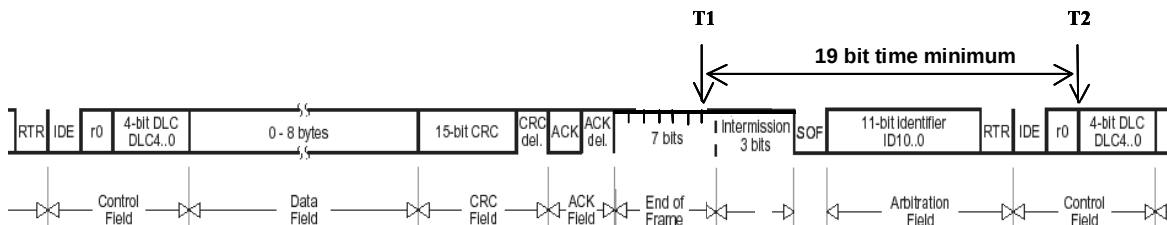
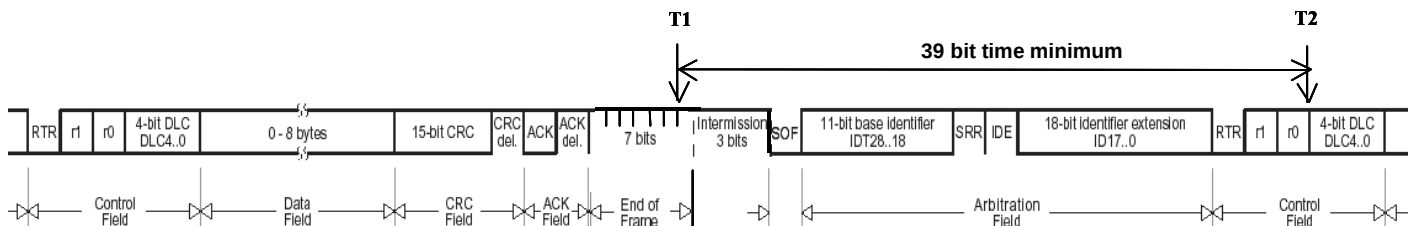
## 17. Transmission after a 3 bit Intermessage

If a Transmit Message Object (MOB) is enabled while the CAN bus is busy with an on going message, the transmitter will wait for the 3-bit Intermission before starting its transmission. This is in full agreement with the CAN recommendation.

If the transmitter lost arbitration against another node, two conditions can occur :

1. At least one Receive MOB of the chip are programmed to accept the incoming message. In this case, the transmitter will wait for the next 3-bit Intermission to retry its transmission.
2. No Receive MOB of the chip are programmed to accept the incoming message. In this case the transmitter will wait for a 4-bit Intermission to retry its transmission. In this case, any other CAN nodes ready to transmit after a 3-bit Intermission will start transmit before the chip transmitter, even if their messages have lower priority IDs.

## Workaround

Always have a Receive MOB enabled ready to accept any incoming messages. Thanks to the implementation of the CAN interface, a Receive MOB must be enable at latest, before the 1<sup>st</sup> bit of the DLC field. The Receive MOB status register is written (RXOK if message OK) immediately after the 6th bit of the End of Frame field. This will leave in CAN2.0A mode a minimum 19-bit time delay to respond to the end of message interrupt (RXOK) and re-enable the Receive MOB before the start of the DLC field of the next incoming message. This minimum delay will be 39-bit time in CAN2.0B. See CAN2.0A CAN2.0B frame timings below.

## Workaround implementation

The workaround is to have the last MOB (MOB14) as "spy" enabled all the time; it is the MOB of lowest priority : If a Mob other than MOB14 is programmed in receive mode and its acceptance filter matches with the incoming message ID, this Mob will take the message. MOB14 will only take messages than no other MOB's will have accepted. MOB14 will need to be re-enabled fast enough to manage back to back frames. The deadline to do this is the beginning of DLC slot of incoming frames as explained above.

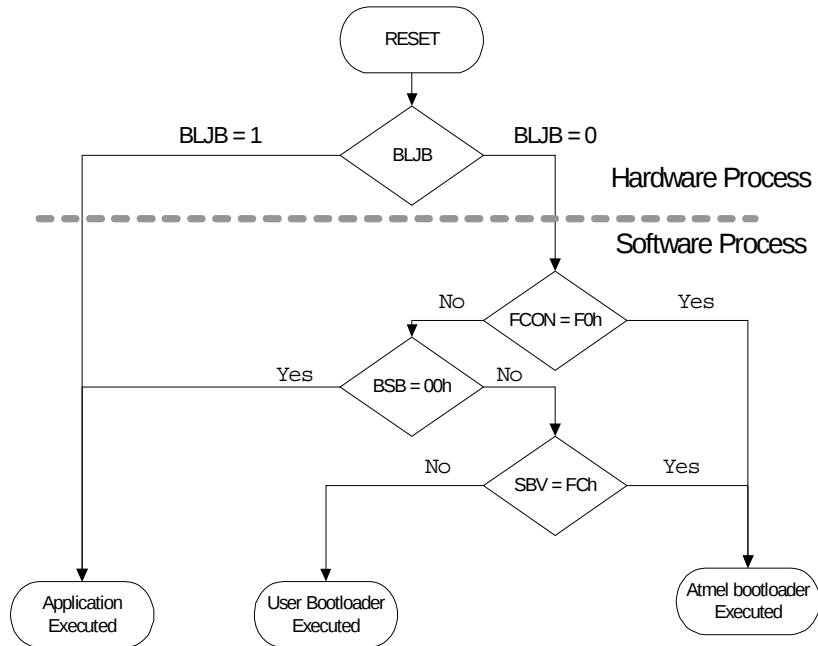
## Version 1.2:

### 4. Boot Process Compatibility

There are some differences between Boot process of bootloader 1.2 and newer versions (see below).

Use the fuse bit BLJB to start the application in both versions.
