# **Tiva™ C Series TM4C129x Microcontrollers Silicon Revisions 1, 2, and 3**

## **1 Introduction**

This document describes known exceptions to the functional specifications for all of the Tiva™ C Series TM4C129x microcontrollers. Note that some features are not available on all devices in the series, so not all errata may apply to your device. See your device-specific data sheet for more details.

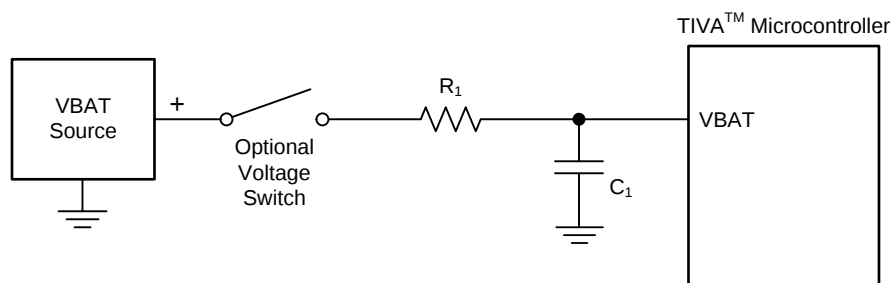
**Figure 2. RC Circuit**

**$V_{BAT}$  Supply pin may be Damaged if the pin Voltage Ramps Faster Than  $0.7 \text{ V}/\mu\text{s}$**

**Description** The  $V_{BAT}$  supply pin may be damaged if the pin voltage ramps faster than  $0.7 \text{ V}/\mu\text{s}$ . Fast  $V_{BAT}$  ramps are a concern when a battery is being connected or the  $V_{BAT}$  supply is hard switched.

**Workaround(s)** An RC circuit as shown should be added to the  $V_{BAT}$  pin to prevent the damage. The  $R_1$  and  $C_1$  should be placed close to the microcontroller for best protection. In systems that do not require Hibernate when the VDD supply is off, the  $V_{BAT}$  pin should be tied to the VDD supply, which typically ramps at a rate slower than  $0.7 \text{ V}/\mu\text{s}$ . The  $R_1$  and  $C_1$  components are not required for a  $V_{BAT}$  supply ramp less than  $0.7 \text{ V}/\mu\text{s}$ .

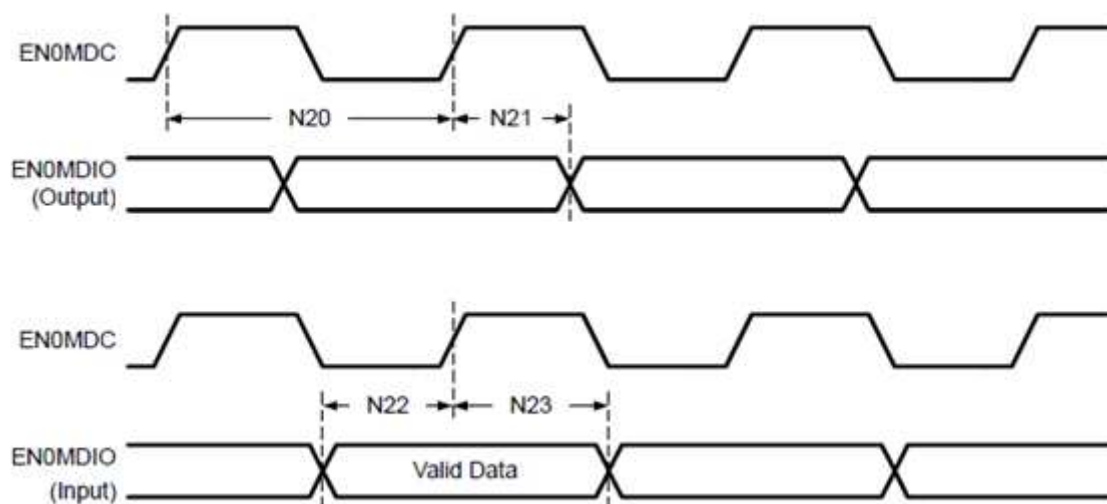
**Description:** The following timing diagram in the Electrical Characteristics for Ethernet Controller AC Characteristics for MII Serial Management is the corrected diagram.

**Workaround(s):** None.

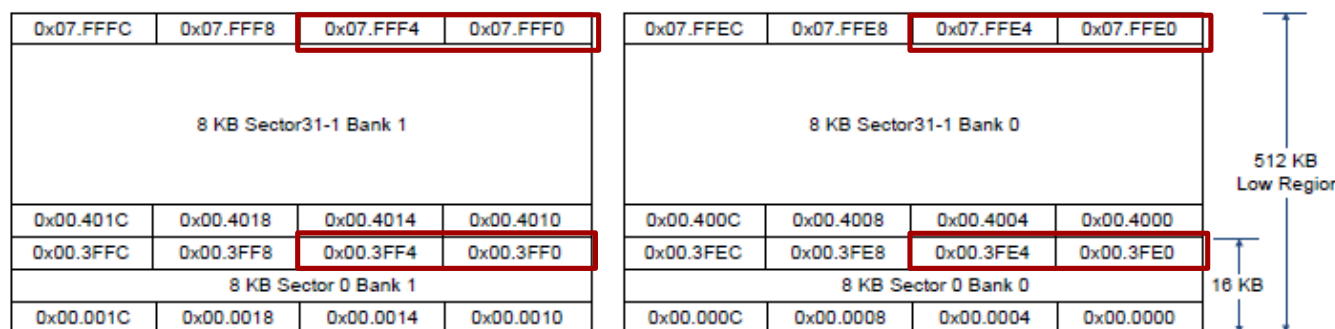
**MEM#15**      ***Specific Flash Locations in any Sector do not get Erased***
**Revision(s) Affected:**    1, 2, and 3.

**Description:**            If only one or both of the first two words of the last line of a sector in a bank are programmed, an Erase of entire Sector, Mass Erase of device, or toggle mass erase does not erase the flash back to all 1's. The diagram below shows the affected words in Sector 0 and Sector 31 of the lower 512KB of Flash.

**Workaround(s):**            Program any other word in the Sector-Bank to allow Sector Erase to work.

**NOTE:**    Toggle Mass Erase or Mass Erase will still not work.

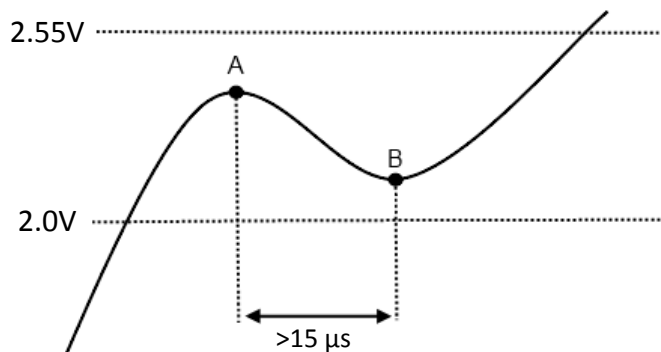
**Figure 3. VDDA Waveform to Avoid Between  $V_{POR}$  min and  $V_{POR}$  max**

**Description:** In very rare cases, a non-monotonic voltage rise of VDDA between the minimum and maximum Power-On Reset Threshold ( $V_{POR}$ ) voltage range, 2.0 V and 2.55 V, can cause the on-chip LDO to not start up. Because the LDO controls the core voltage (VDDC), the device cannot start up correctly in this situation. If the LDO fails to start, power cycle the device until a successful power up occurs. A software or hardware reset cannot restart the LDO.

**Workaround(s):** A monotonic voltage rise of VDDA prevents this issue from occurring; however, a perfect monotonic ramp is difficult to achieve, particularly during LDO inrush. The risk of encountering this issue can be minimized by performing one of the following:

- If the VDD and VDDA pins are connected directly to the same power source, at every possible point A and point B along the VDDA waveform between 2.0 V and 2.55 V, point B must never fall below point A after 15  $\mu$ s, as shown in [Figure 3](#).
- Use a separate power supply for VDDA to reduce noise and isolate it from the effects of LDO inrush. At every possible point A and point B along the VDDA waveform between 2.0 V and 2.55 V, point B must never fall below point A after 15  $\mu$ s, as shown in [Figure 3](#). The separate power supply will make it easier to avoid this condition.

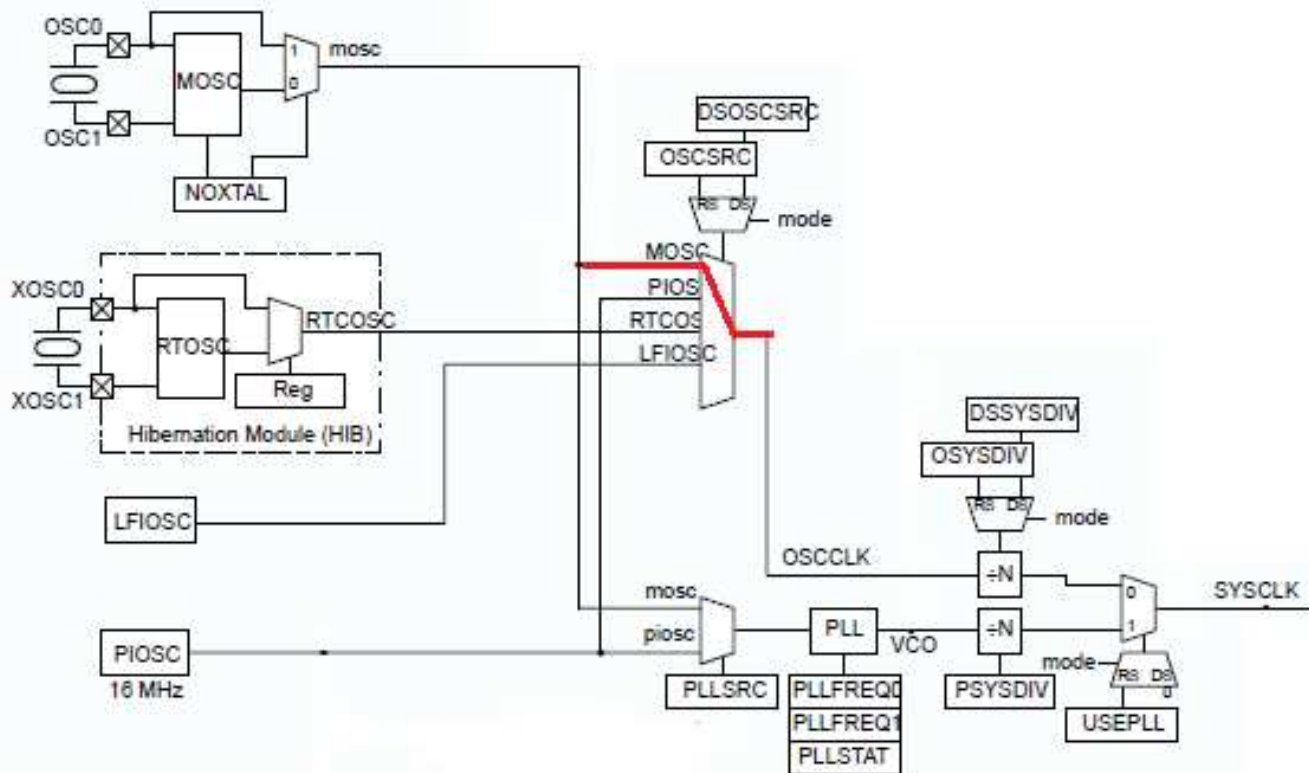
## SYSCTL#23 *MOSC as the Source to OSCCLK may Cause a bus Fault on Reset*

**Description:** MOSC as the source to the OSCCLK may cause a bus fault on reset. This may happen even when using the PLL as SYSCLK and configuring the MOSC as the source for OSCCLK. Please see the following image on the affected clock path.

In TivaWare 2.1.2 or earlier, the SysCtlClockFreqSet sets the PLL source as MOSC when the API is called with the parameter SYSCTL\_OSC\_MAIN. It sets the OSCCLK as MOSC which is not required and may cause this issue. This issue may occur when using the ROM version of the API.

**Workaround(s):** Do not use MOSC as the OSCCLK source. There are two workarounds for application using SysCtlClockFreqSet API.
