# **TMS320C6748 Fixed- and Floating-Point DSP Silicon Revisions 2.3, 2.1, 2.0, 1.1 and 1.0**

## **Silicon Errata**

Literature Number: SPRZ303H  
June 2009–Revised March 2014

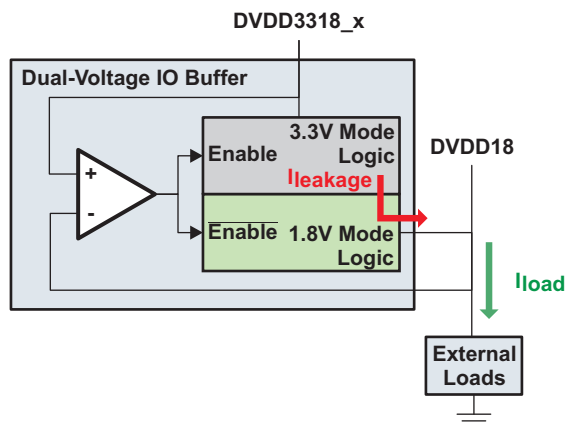
Figure 8. Error State of the IO buffer during Zone G

As DVDD3318\_x exceeds DVDD18 +  $V_T$ , some of the circuitry across the boundary of the two voltage domains will turn on and causes a leakage current (in red) to flow between the two voltage domains. This current pulls up the DVDD18 supply unless the power source providing that supply can oppose it or unless the load current is strong enough to counteract it.

If DVDD18 continues to rise as DVDD3318\_x ramps, the comparator never sees enough difference between the two supplies to switch to 3.3V mode.

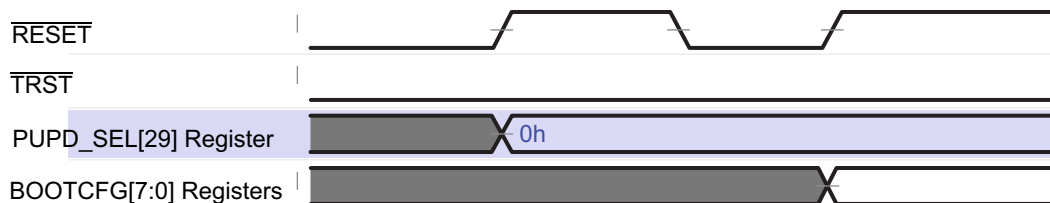
**Figure 10. Initialization of PUPD\_SEL[29] and BOOTCFG[7:0] Registers with Weak or No External Pull Resistors on BOOT[7:0] Pins**

Internal pullups being enabled on the BOOT[7:0] pins may result in boot failures. If weak external pulldown resistors are used on the PCB to select the boot mode, they may not be able to overpower the internal pullups. This can result in the wrong boot mode being latched in the BOOTCFG[7:0] register when coming out of Reset.

Once the device is out of Reset, the PUPD\_SEL[29] register is initialized, and the internal pulldown resistors for the BOOT[7:0] pins are all enabled. Issuing a second Power-On Reset ( $\overline{\text{POR}}$ ) results in the intended boot mode being latched, since the pins are internally pulled down as expected.

Figure 10 shows the behavior of the PUPD\_SEL[29] register before and after reset. Assuming weak or no external pull resistors are on the BOOT[7:0] pins, the BOOTCFG register will latch the unknown values after the device initially comes out of Reset. Note that, TRST **must** always be low in order to issue a POR and latch the boot pin values -- the boot pins are not latched after a Warm Reset.
