## **TMS320F2803x Piccolo™ MCUs**

### **Silicon Revisions A, 0**

## **1 Introduction**

This document describes the silicon updates to the functional specifications for the TMS320F2803x microcontrollers (MCUs).

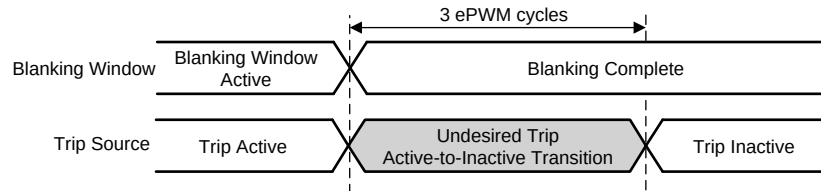
**Figure 3. Undesired Trip Event and Blanking Window Expiration**

The blanking window is typically used to mask any PWM trip events during transitions which would be false trips to the system. If an ePWM trip event remains active for less than three ePWM clocks after the end of the blanking window cycles, there can be an undesired glitch at the ePWM output.

Figure 3 illustrates the time period which could result in an undesired ePWM output.
