## ***TMS320F2806x Piccolo™ MCUs Silicon Revisions B, A, 0***

This document describes the silicon updates to the functional specifications for the TMS320F2806x microcontrollers (MCUs).

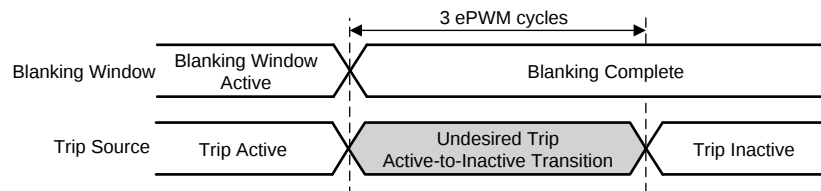
**Figure 6. Undesired Trip Event and Blanking Window Expiration**

**Details** The blanking window is typically used to mask any PWM trip events during transitions which would be false trips to the system. If an ePWM trip event remains active for less than three ePWM clocks after the end of the blanking window cycles, there can be an undesired glitch at the ePWM output.

Figure 6 illustrates the time period which could result in an undesired ePWM output.
