# ***TMS320F280x, TMS320C280x, TMS320F2801x DSPs Silicon revisions C, B, A, 0***

This document describes the silicon updates to the functional specifications for the TMS320F2809, TMS320F2808, TMS320F2806, TMS320F2802, TMS320F2801, TMS320C2802, TMS320C2801, TMS320F28016, and TMS320F28015 digital signal processors (DSPs).

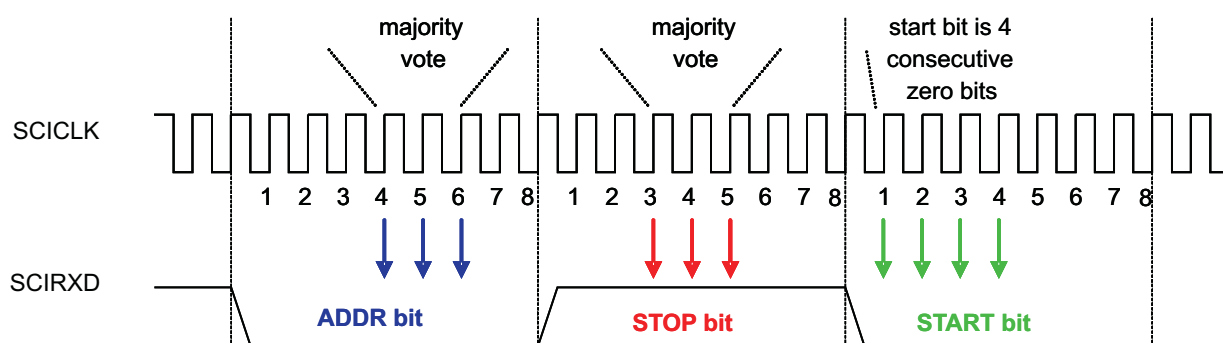
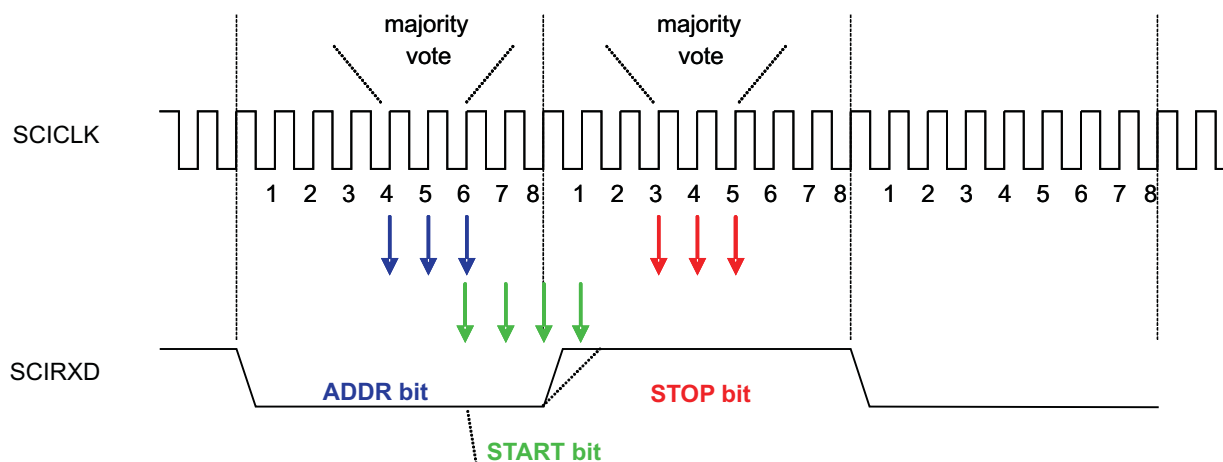
**Figure 3. Difference Between Expected and Erroneous Operation of START Bit**

SCI does not look for STOP bit after the ADDR bit. Instead, SCI starts looking for the start bit beginning on sub-sample 6 of the ADDR bit. Slow rise-time from ADDR to STOP bit can cause the false START bit to occur since the 4th sub-sample for the start bit may be sensed low.

Program the baud rate of the SCI to be slightly slower than the actual. This will cause the 4th sub-sample of the false START bit to be delayed in time, and therefore occur more towards the middle of the STOP bit (away from the signal transition region). The amount of baud slowing needed depends on the rise-time of the signal in the system. Alternatively, IDLE mode of the SCI module may be used, if applicable.
