*TMS570LS12x/11x Microcontroller*

**Silicon Revision B**

# Silicon Errata

Literature Number: SPNZ199F  
February 2013–Revised May 2016

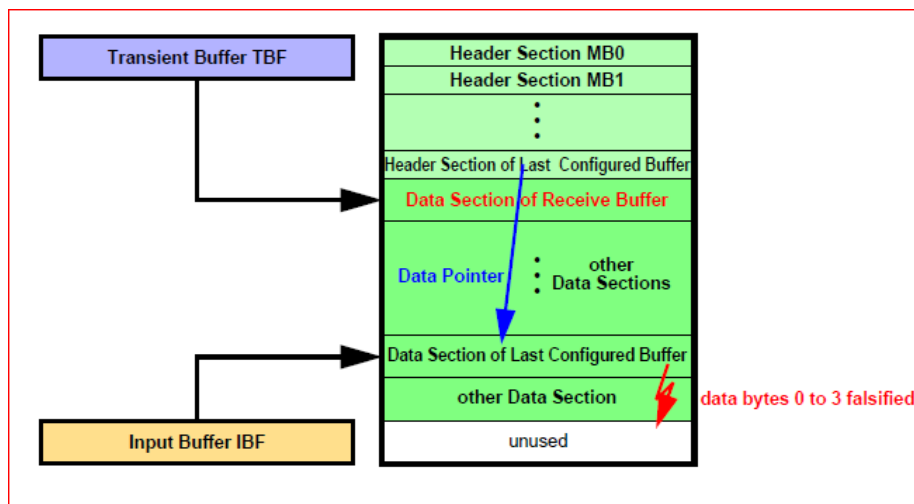
**Figure 5. Second Fail Mode**

2) When a message is transferred from IBF to the Last Configured Buffer in the Message RAM, it may happen, that at the end of the transfer of the Data Section one additional write access overwrites the following word, which may be the first word of another message's Data Section in the Message RAM (see [Figure 5](#)).
