*TMS570LS31x/21x Microcontroller*

**Silicon Revision C**

# **Silicon Errata**

Literature Number: SPNZ195G  
February 2013–Revised May 2016

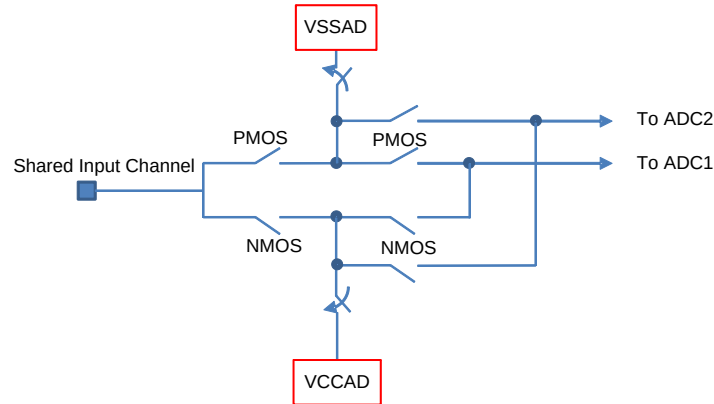
**Figure 2. Shared Input Channel in "Open" State**

The PMOS and NMOS switches are open indicating that this shared input channel is not currently being sampled either by ADC1 or by ADC2. Also, there are switches to VCCAD and VSSAD that are closed. If any current is injected into this analog input, any leakage through the open PMOS switch will be shunted to VSSAD. These switches to VSSAD and VCCAD are opened as soon as this shared input channel is being sampled by either ADC1 or ADC2.

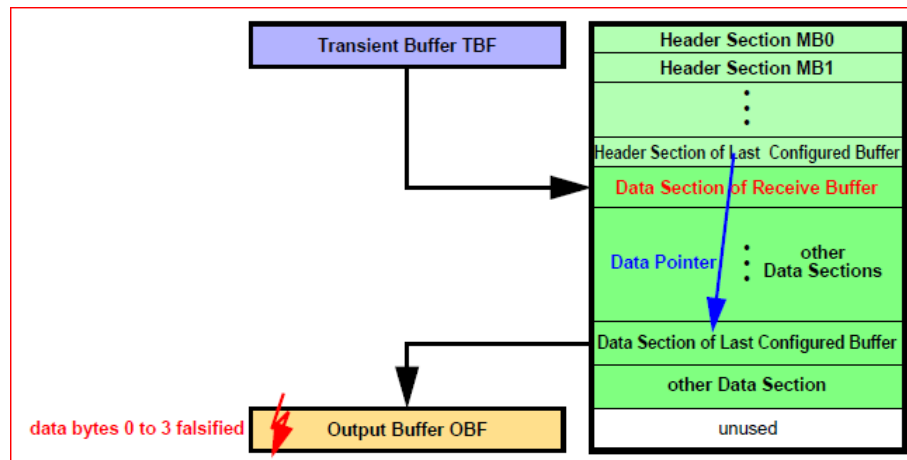
**Figure 4. First Fail Mode**

| <b>Implications</b> | <p>1) When a message is transferred from the Last Configured Buffer in the Message RAM to the OBF and PLC = 127 it may happen, that at the end of the transfer the OBF word on address 00h (payload data bytes 0 to 3) is overwritten with unexpected data (see <a href="#">Figure 4</a>).</p> |

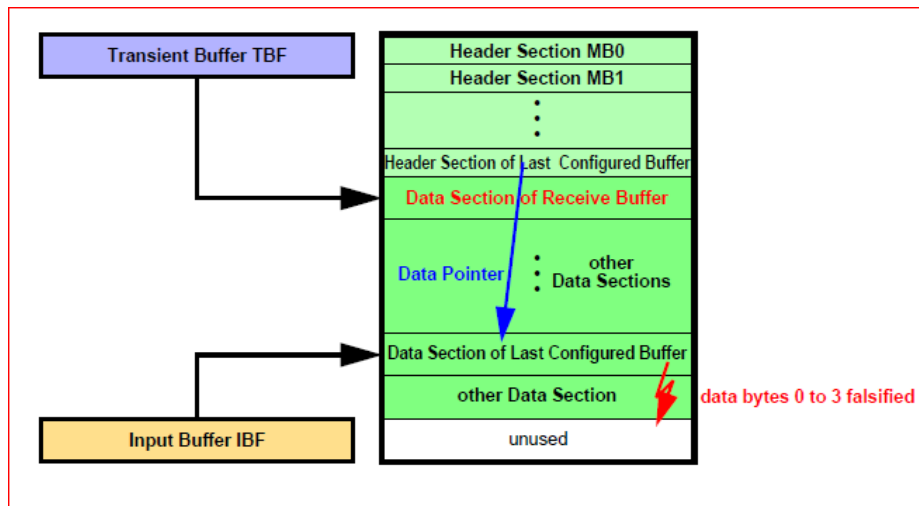
Figure 5. Second Fail Mode

2) When a message is transferred from IBF to the Last Configured Buffer in the Message RAM, it may happen, that at the end of the transfer of the Data Section one additional write access overwrites the following word, which may be the first word of another message's Data Section in the Message RAM (see [Figure 5](#)).
