## **TMS320F2837xD Dual-Core MCUs**

### **Silicon Revisions C, B, A, 0**

## **1 Introduction**

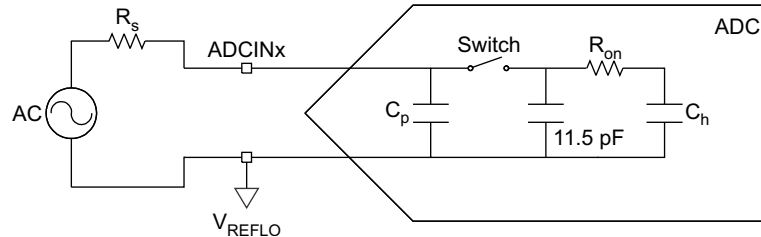
**Figure 3. Single-Ended Input Model**

The ADC input model should be used to select the sample-and-hold (S+H) duration for each ADC input. For the revisions affected, if the currently converting channel is an even-numbered channel and the previously converted channel was an odd-numbered channel (or vice versa), then the 12-bit input model will not accurately predict ADC input performance. Under these conditions, an additional capacitance should be added to the model. This capacitance has a value of 11.5 pF and should be placed between the S+H switch and  $R_{on}$  as shown in Figure 3.
